Storm Drain Condition Assessment Report

W 32nd AVENUE and E. 33rd AVENUE UPGRADES

STORM DRAIN CONDITION ASSESSMENT

AUGUST 2017

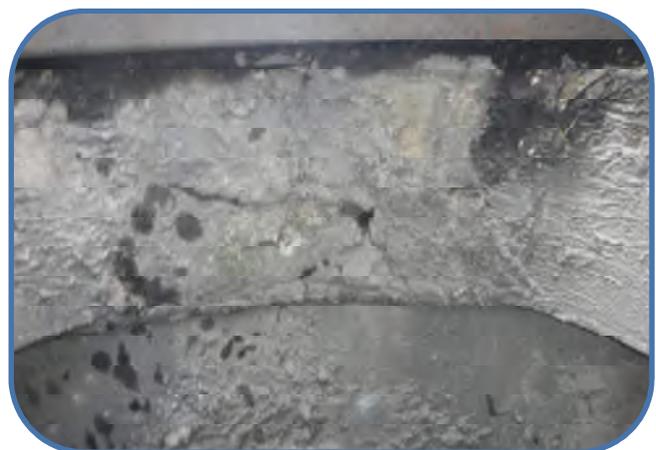
Reducing slab: 1-8 inch with a grade score of 2 crack in reducing slab not separated

crack in reducing slab not separated

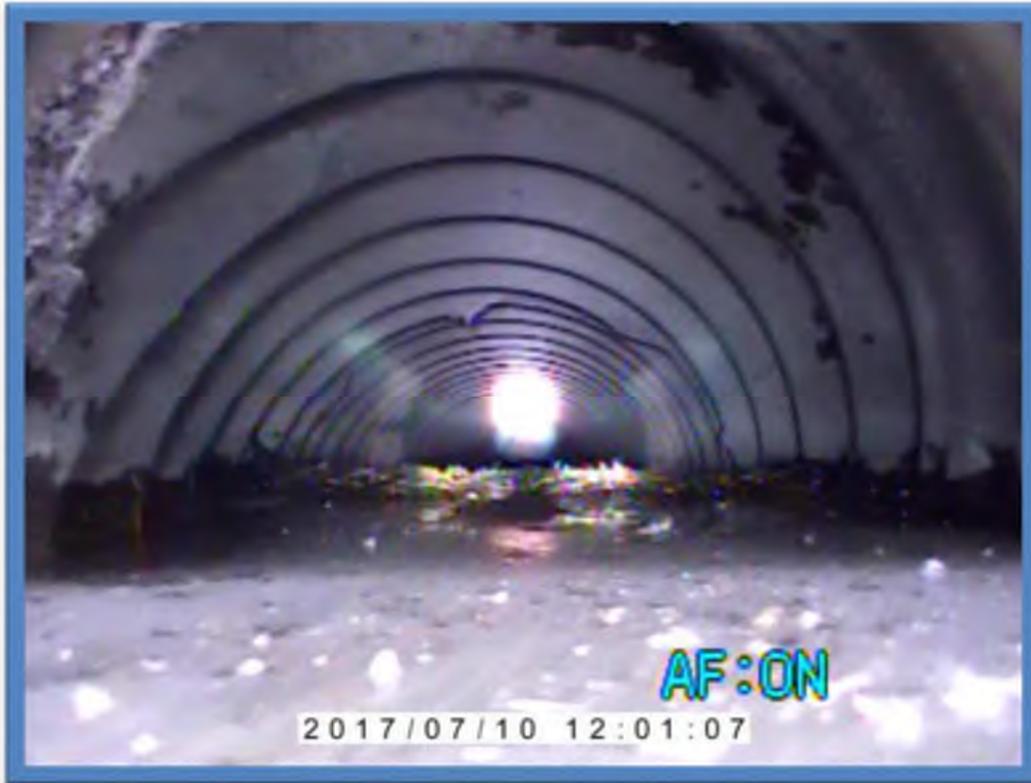
- Up to 6-inches of sediment buildup in invert (see photo)
- Invert soft when probed with moderate force

6-inches of debris in invert blocking flow

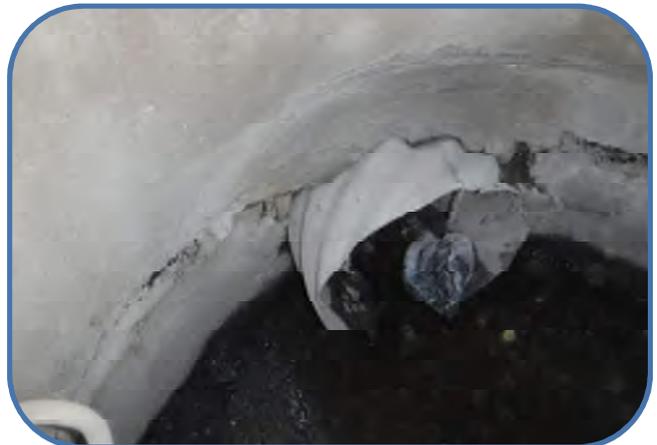
Effluent Pipe Connection: Effluent pipe connection protrudes 6 inches grout is flaking and cracking, Grade score of 3.

effluent cracked around pipe connections

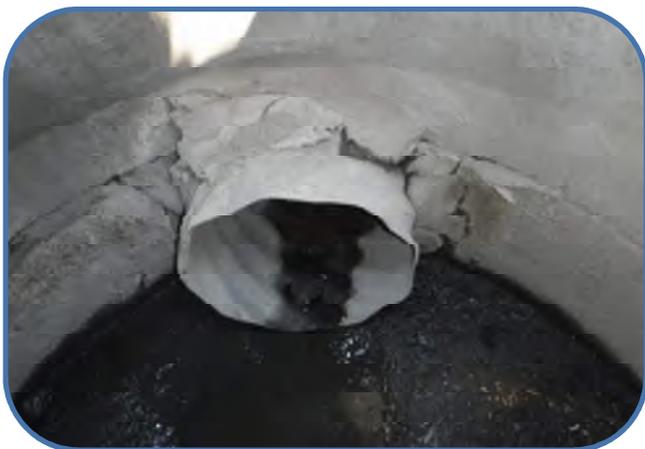
Base: Too much debris to determine height of base, with a grade score 3, base is cracked near pipe connections

pipe 3 influent, sump full of debris

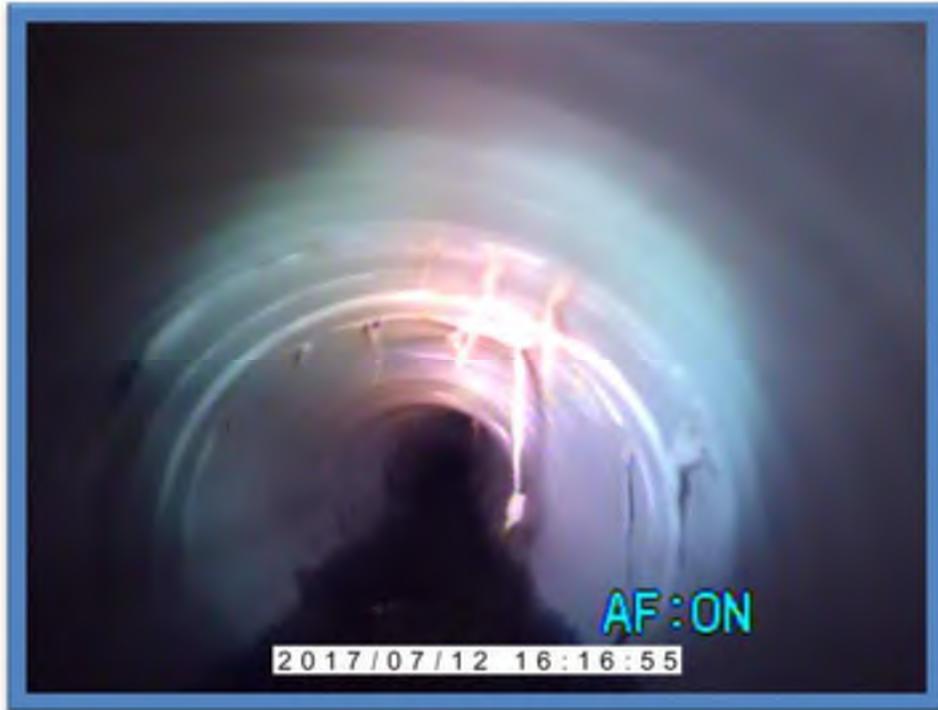
Photo 1-root intrusion at crown

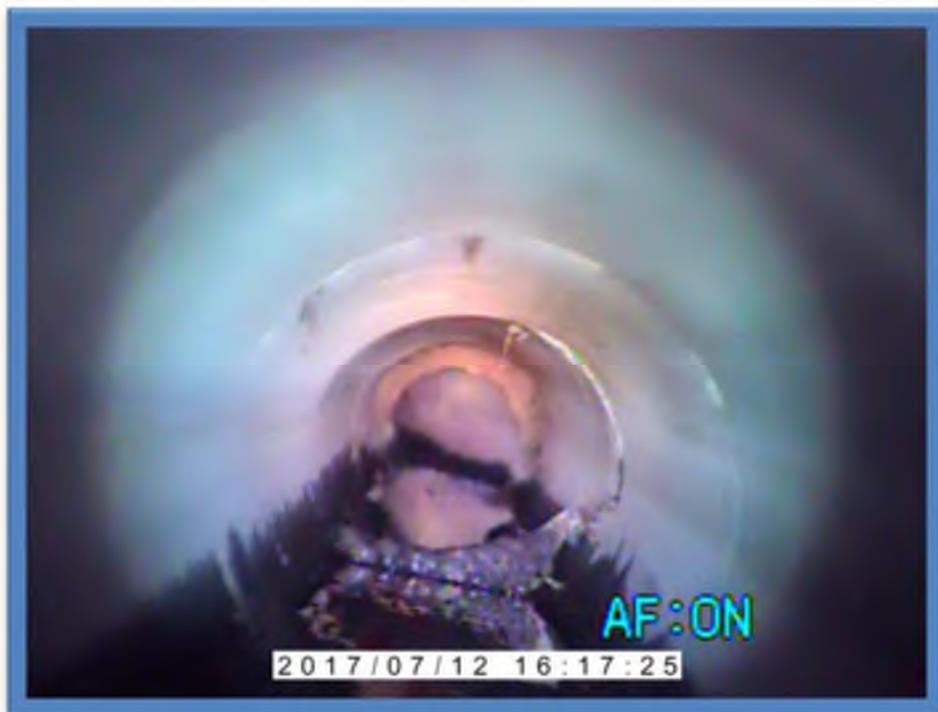
- 2-inches of debris in invert
- Root intrusion in pipe see photo 2
- Invert soft when probed with moderate force

Photo 2-root intrusion at 4 o'clock

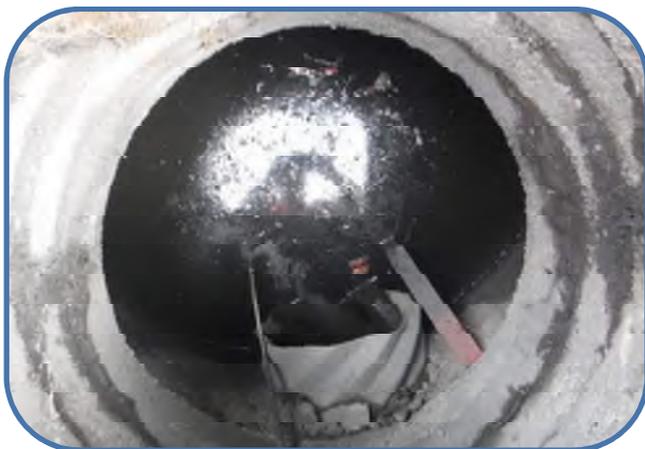
12-inch effluent and cracked grout

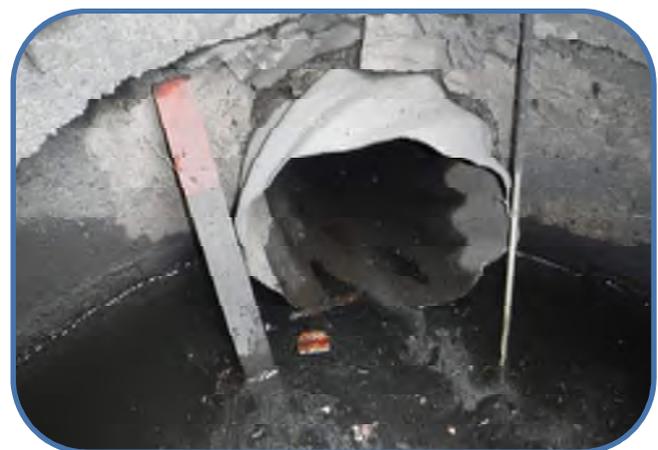
grout cracked

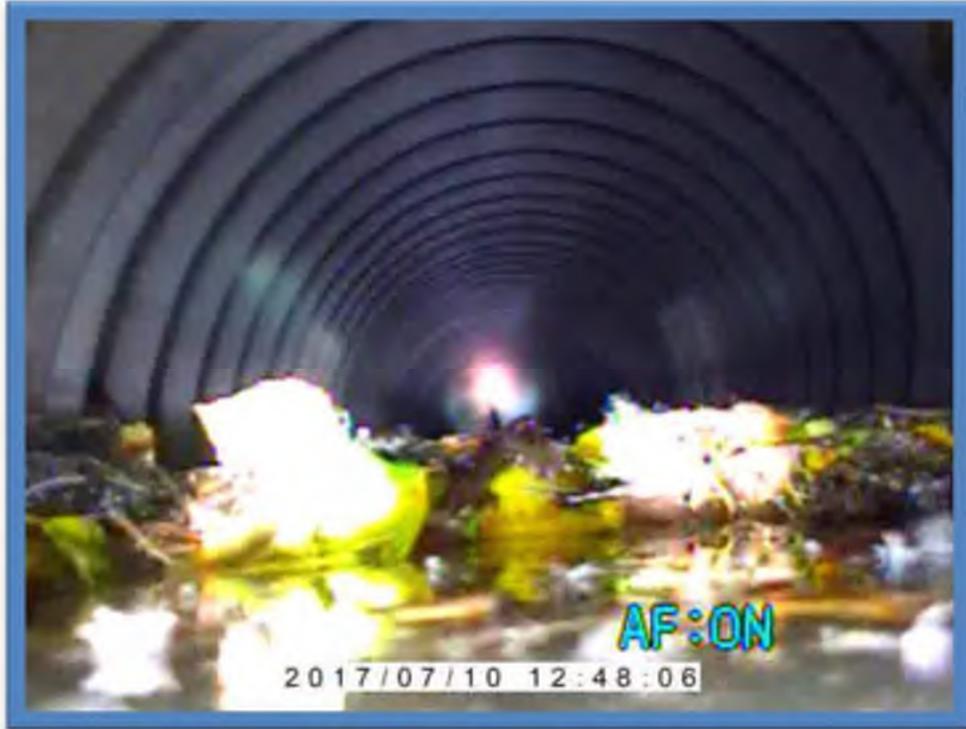
Photo 1-6 inches of debris in invert blocking flow

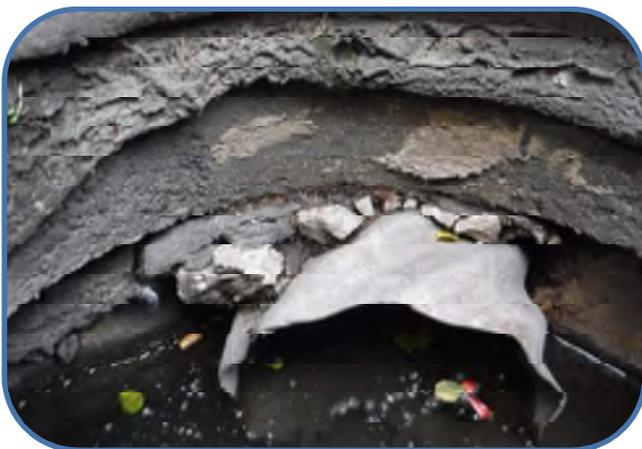
12-inch effluent cracked grout

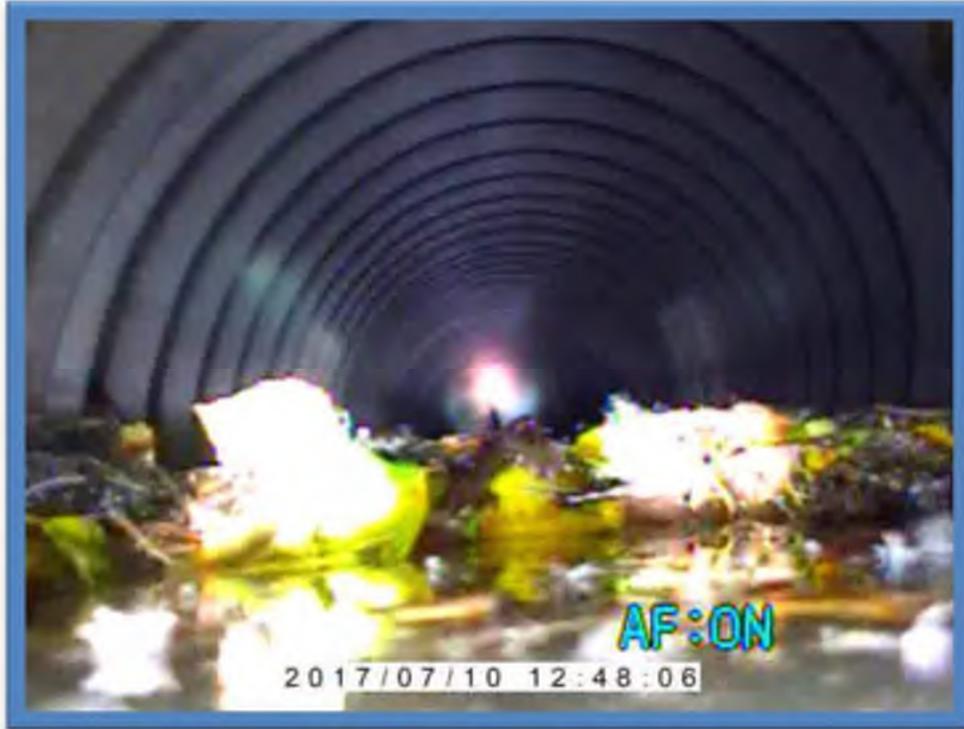
- Up to 6-inches of sediment buildup in invert blocking most of photo (see photo 1)
- Invert soft when probed with moderate force

Photo 1-6 inches of debris in invert blocking flow

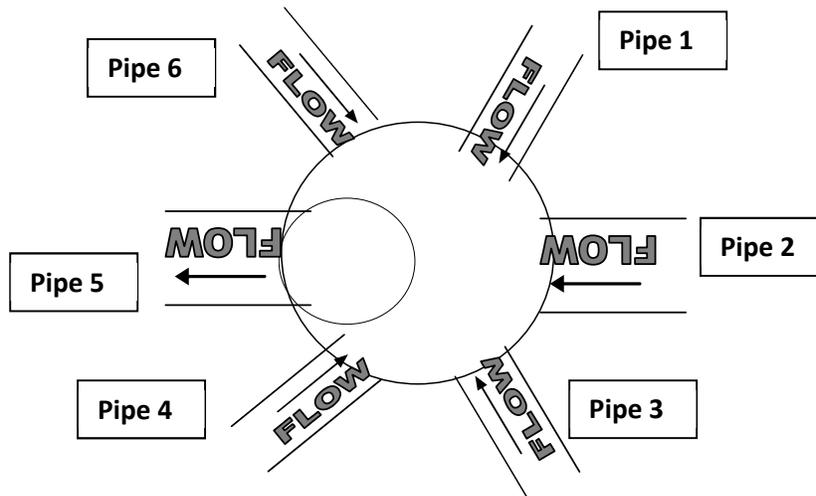
MH 1631-052 looking north

Additional Comment: frame is offset from chimney, inverts were probed on manhole and all were soft.

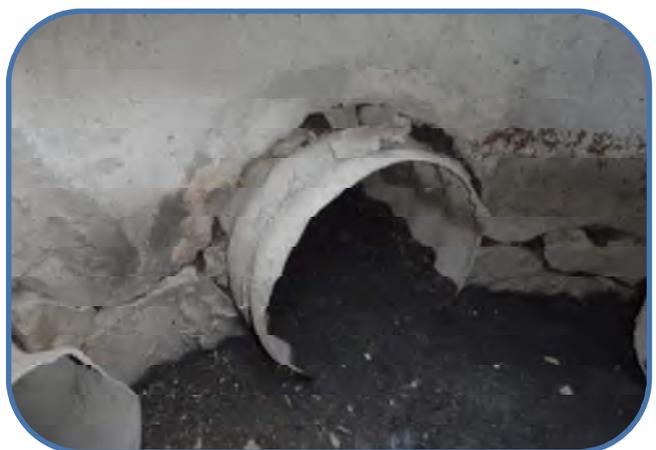
Effluent Pipe Connection: Effluent pipe connection protrudes 4 inches grout is flaking and cracking, grade score of 3.

effluent with crack between pipe connections

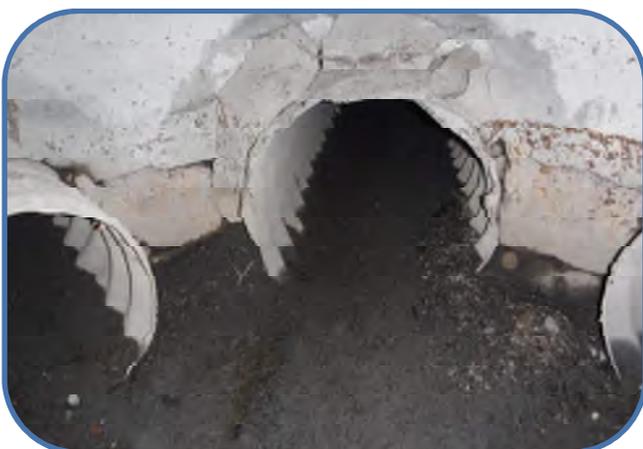
pipe 3-influent sump full of debris

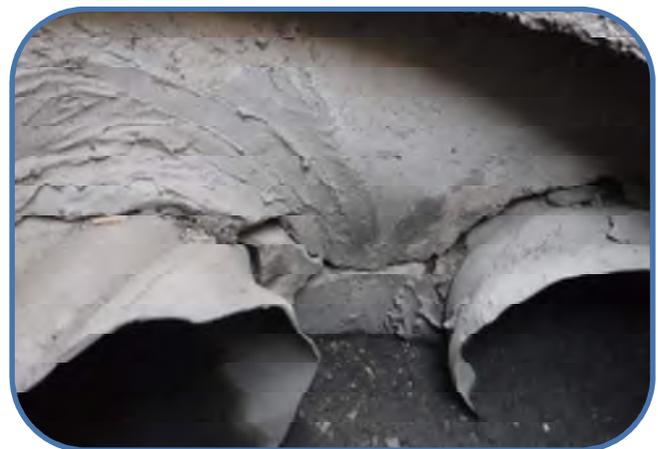
Base: Too much debris to determine height of base, with a grade score 4, circumferential crack through pipe connections

pipe 5-effluent and pipe 4- influent cracked base

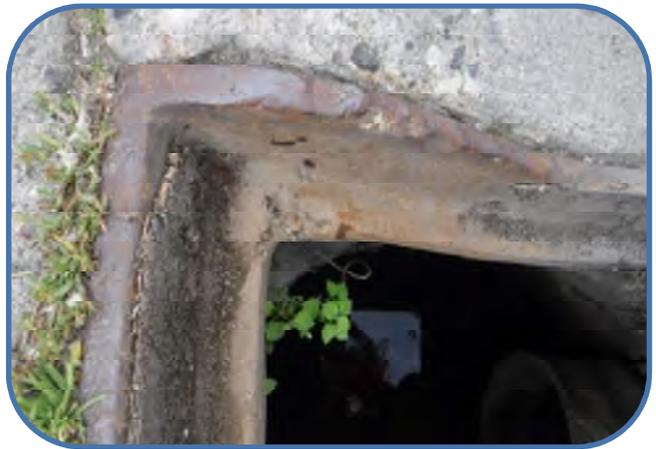
Additional Comment: frame and cover have corrosion that is leading to minor metal loss

missing metal on frame

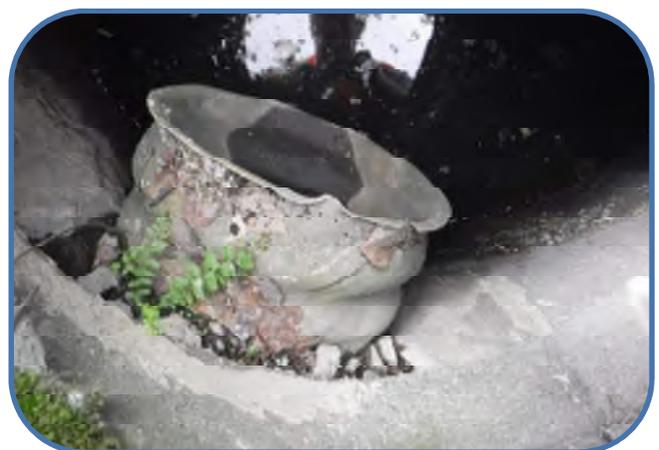
Effluent Pipe Connection: 7-inch protrusion no grout with a grade score of 4.

grout cracked and missing

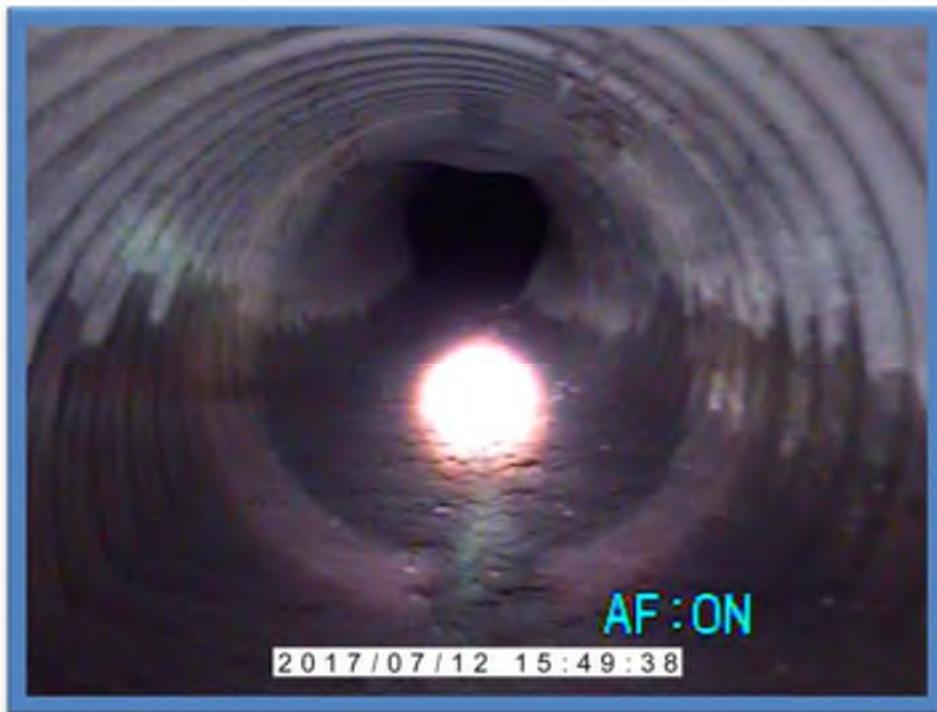
- 2-inches of debris invert in pipe
- Dent in top of pipe, see photo 1

Photo 1-Dent in crown of pipe between 11 o'clock and 1 o'clock

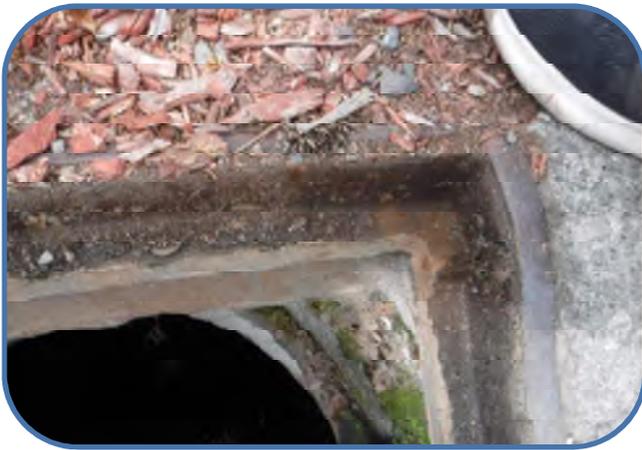
Cover/Lid: 25x18-inch, CI, with a grade score of 3 rolled curb corrosion present on manhole cover and frame leading to metal loss

MH frame corrosion on frame

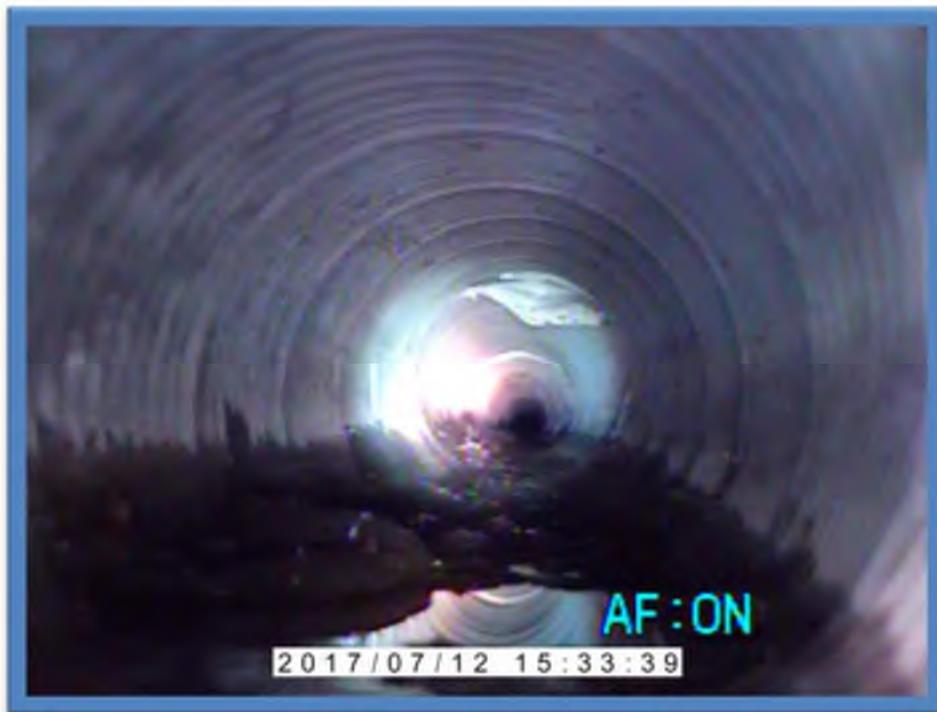
Photo 1-Dent in crown of pipe between 11 o'clock and 1 o'clock

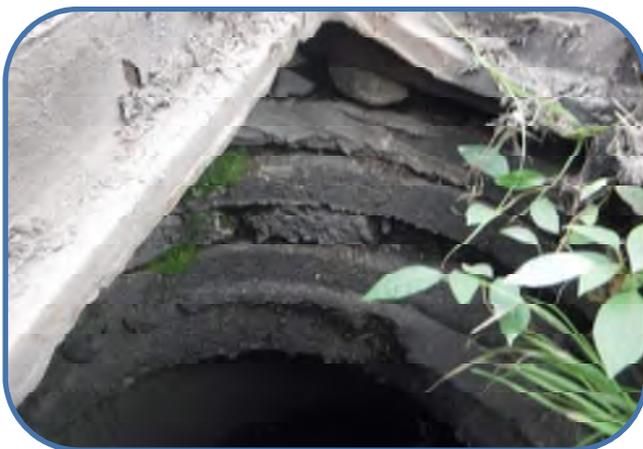
Additional Comment: Cracked chimneys, hole in chimneys approximately 3-inches tall and 6 inches long

cracked chimney with hole

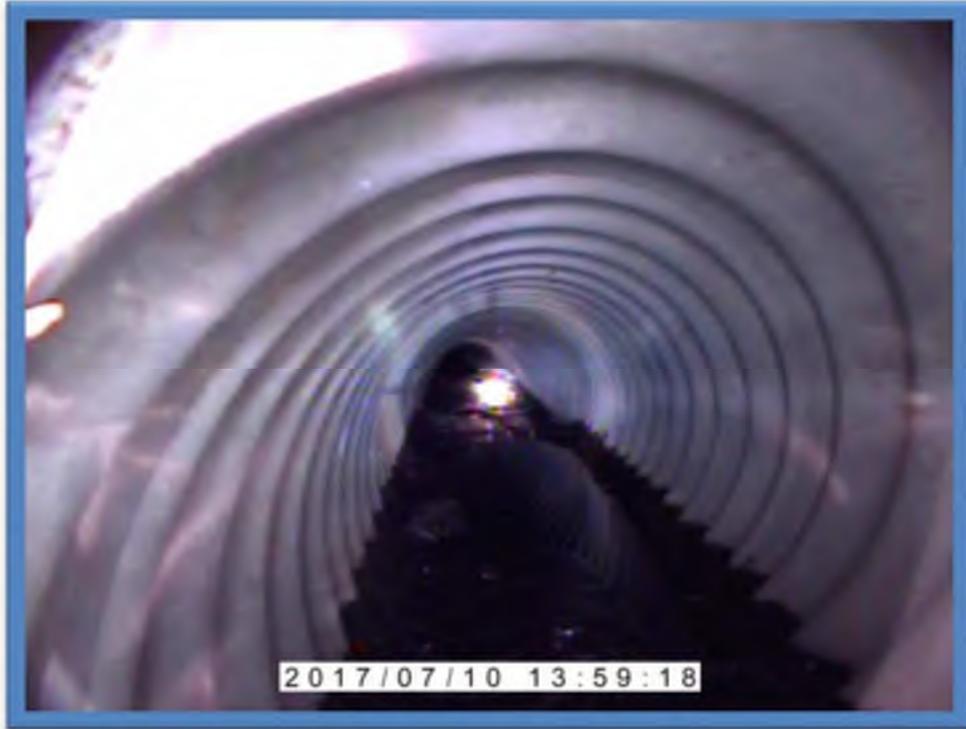
- 5 inches of debris blocking flow, see photo 1

Photo 1-6-inches of debris in invert blocking flow

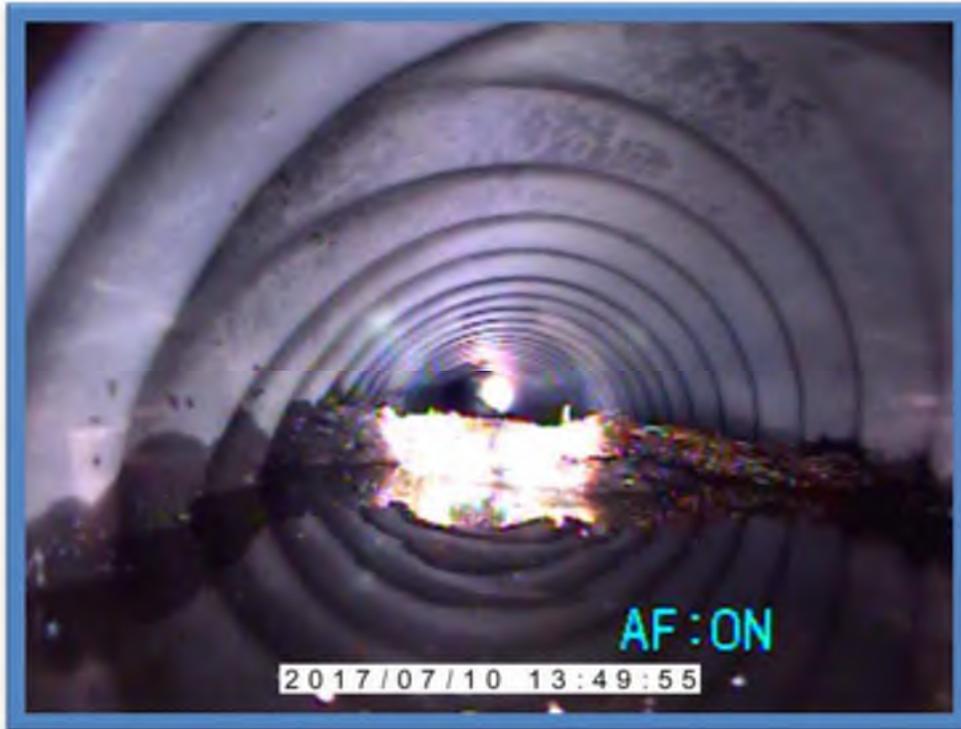
Photo 1-6-inches of debris in invert blocking flow

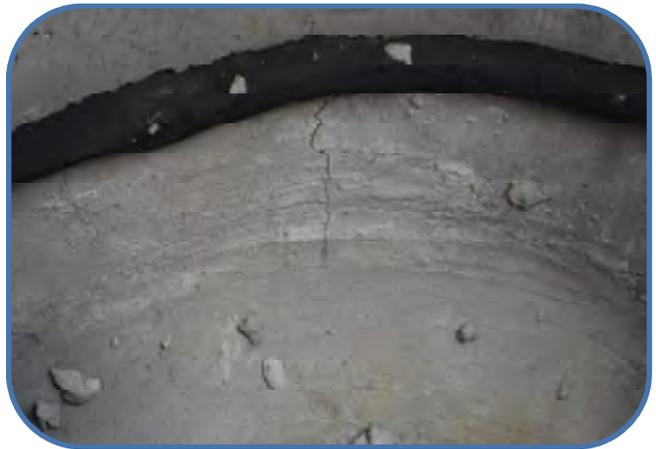
Base: 36-inch with a grade score 2, small crack in base

Additional Comment: Manhole in good condition crack above effluent pipe is possibly in grout not base could not determine.

small crack in base above effluent pipe
