32ND AND 33RD Avenue Upgrades

32nd and 33rd Avenue Upgrades

SEWER MANHOLE INSPECTION REPORT

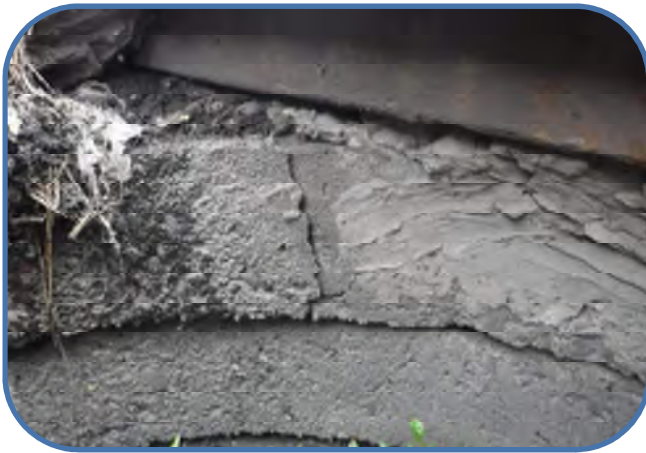
Chimney: 2-chimneys totaling 10-inches with a grade score of 3, chimney is cracked.

cracked chimney

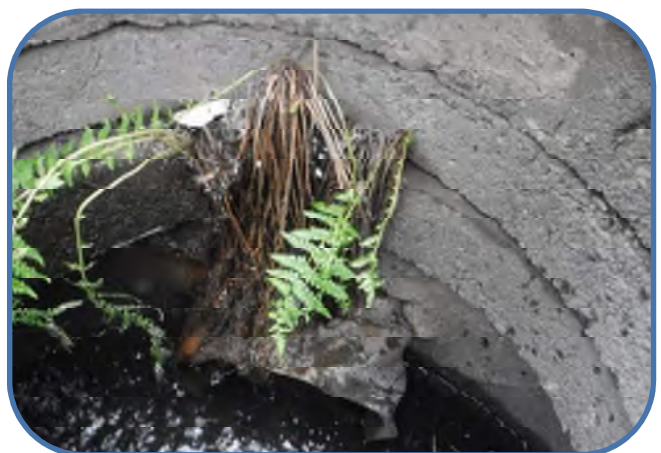
vegetation growing between chimneys and
reducing slab

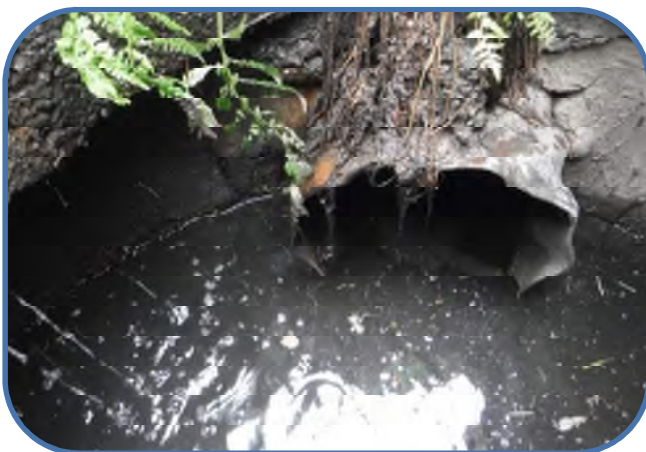
Effluent Pipe Connection: 3-inch protrusion grout is flaking and cracked, grade score of 3.

12-inch effluent cracked grout

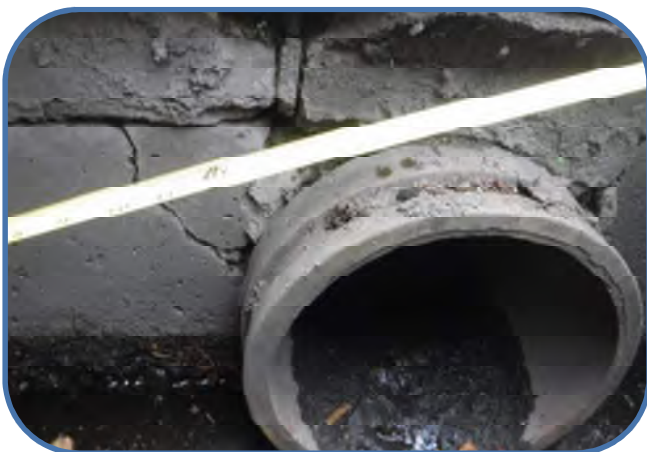
Effluent Pipe Connection: 1-inch protrusion grout missing hole by connection, grade score of 3

grout cracked on base effluent pipe

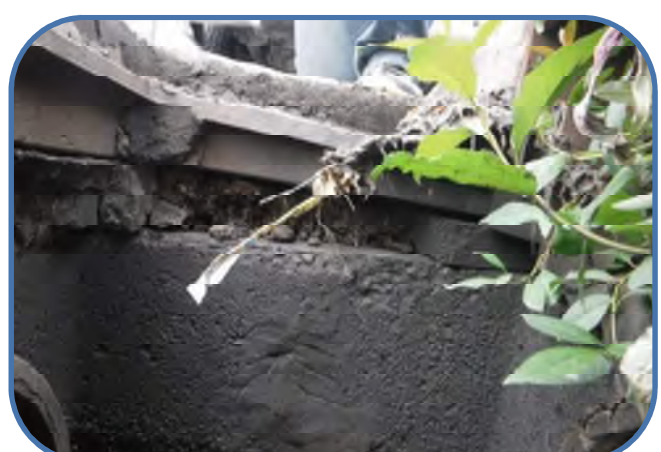
grout cracked in chimney

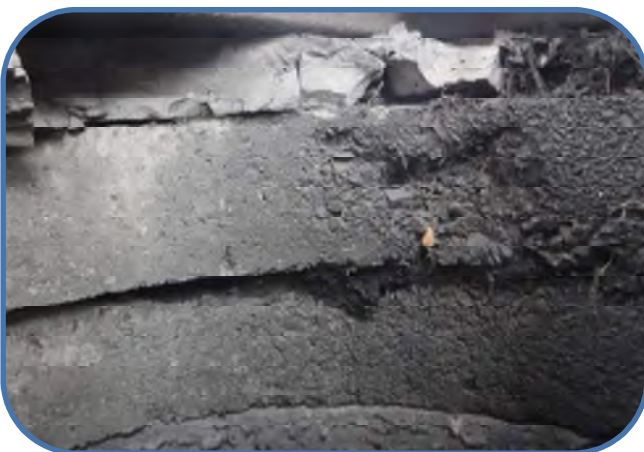
grout cracked between frame and chimney

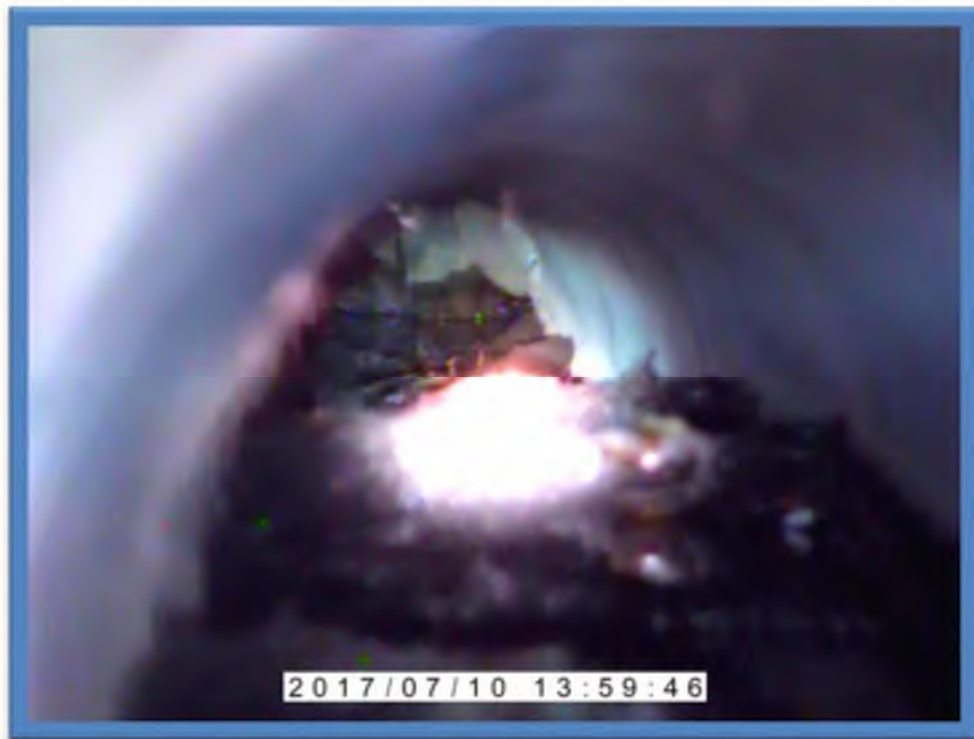
- 5 inches of debris blocking flow (see photo 1)
- Invert of pipe entering manhole was corroded and missing

Photo 1-5 inches of debris in invert blocking flow

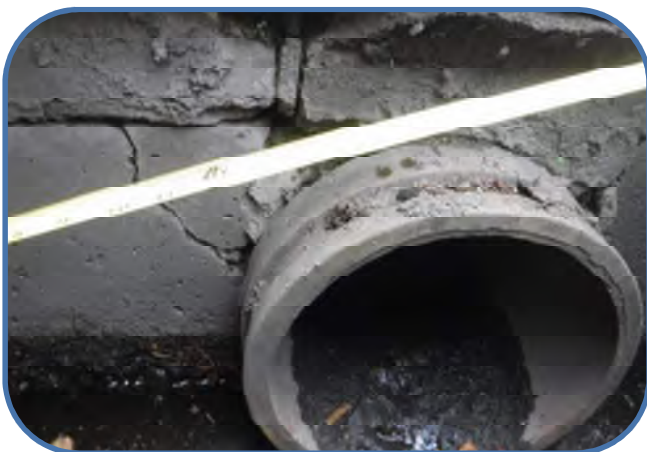
Base: too much debris to measure with a grade score of 3. Cracks are present in base

cracks on base effluent pipe

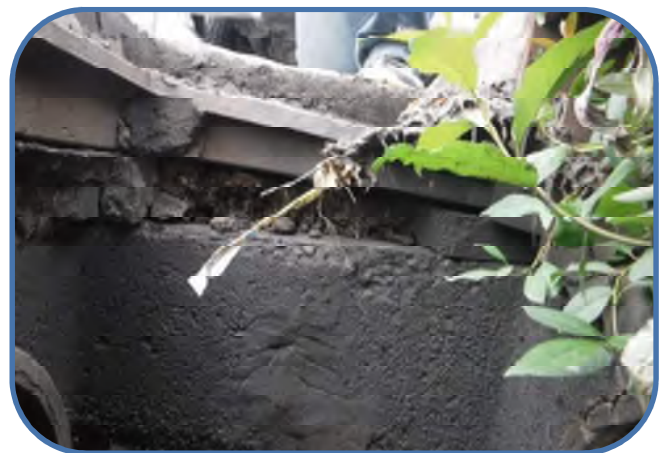
cracks in chimney

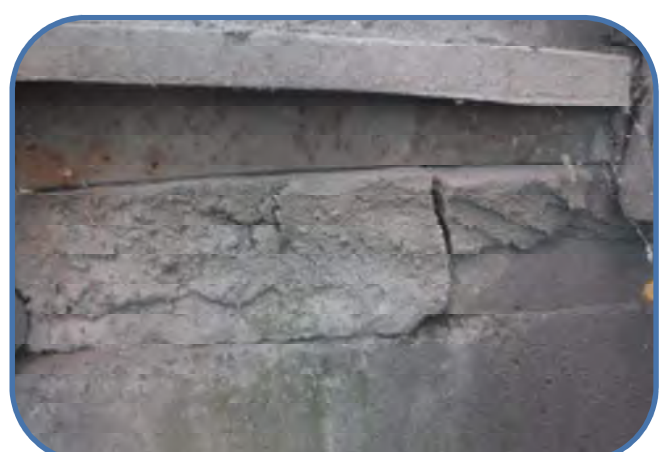
Chimney: 1-5 inch chimney with, grade score of 4 multiple cracks and missing grout.

cracked and broken chimney

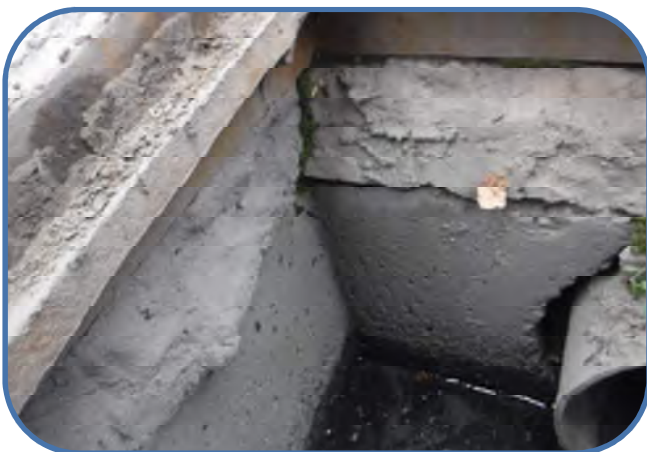
Chimney: 1-4 inches of chimneys with a grade score of 3 cracks in chimney

grout cracked on chimney

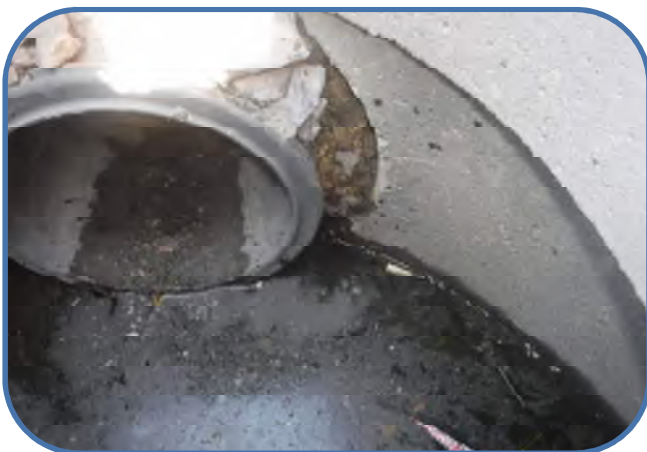
Effluent Pipe Connection: Effluent pipe connection grout is flaking and missing grout, effluent protrudes 3 inches, grade score of 4.

effluent missing grout

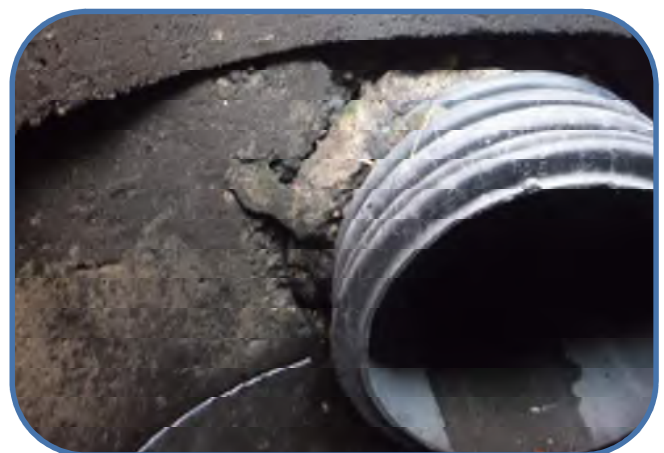
Effluent Pipe Connection: Effluent pipe connection grout is flaking and missing grout, effluent protrudes 6-inches, grade score of 3.

missing grout

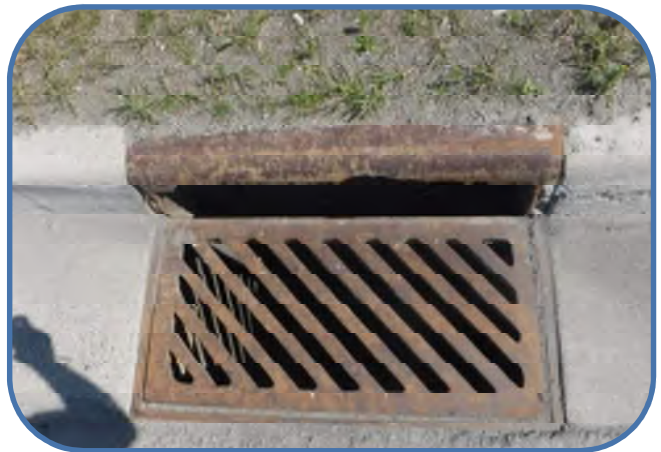
Additional Comment: Pipe is likely a type of fiberglass polymer pipe. Frame is broken on the inlet see photos

broken frame

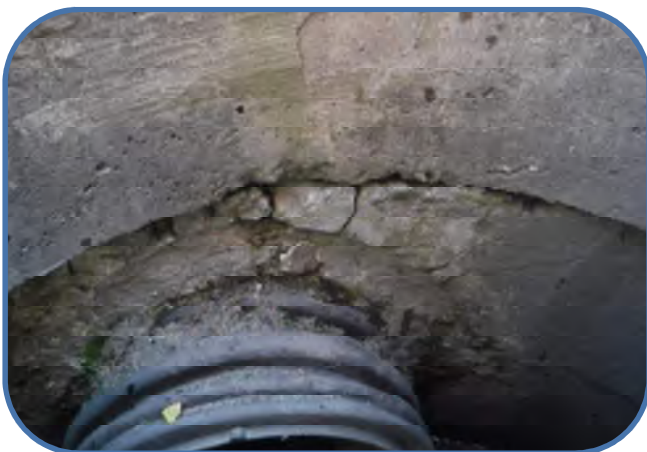
Effluent Pipe Connection: Effluent pipe connection grout is flaking and missing grout, effluent protrudes 6 inches, grade score of 3.

effluent cracked grout

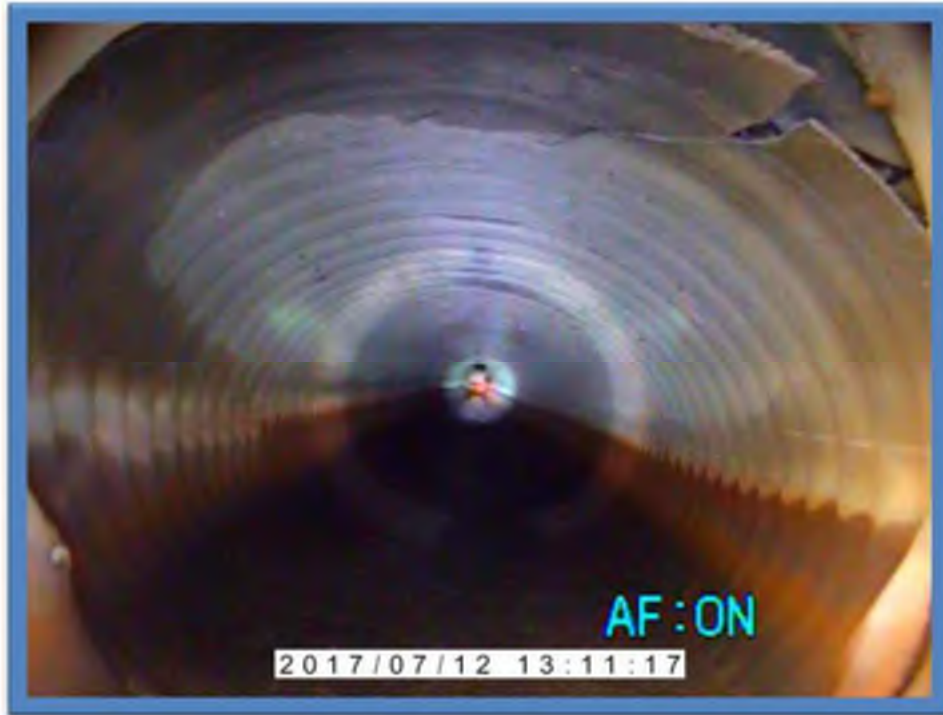
- Pipe damaged at pipe connection between 11 o'clock and 1 o'clock position, see photo 1

Photo 1-Pipe damage at crown of pipe at manhole connection

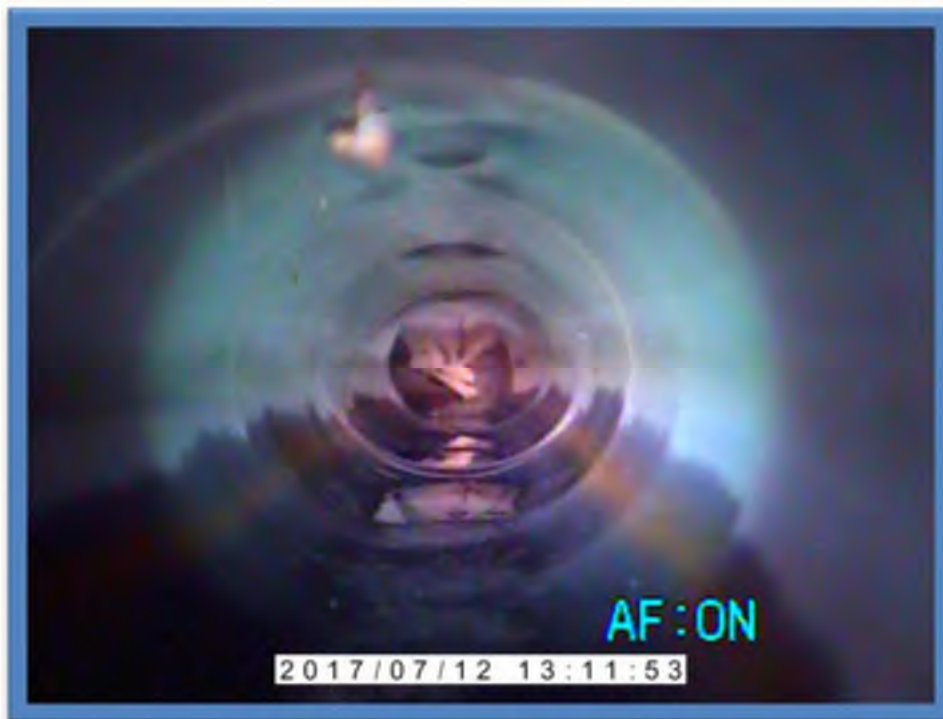
- Ovality observed in pipe, approximately 5%, See photo 2

Photo 1-Ovality in pipe section near manhole 1631-132

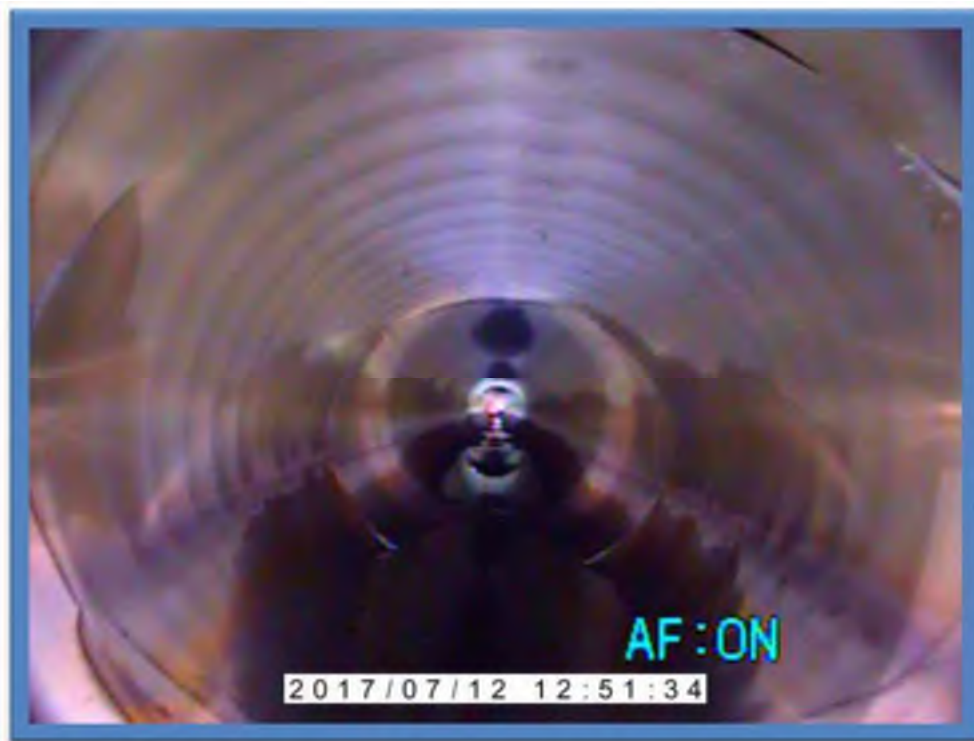
- Approximately 5% ovality observed in pipe

Photo 1-Ovality in pipe segment. Pipe deformed down. Ovality is approximately 5%

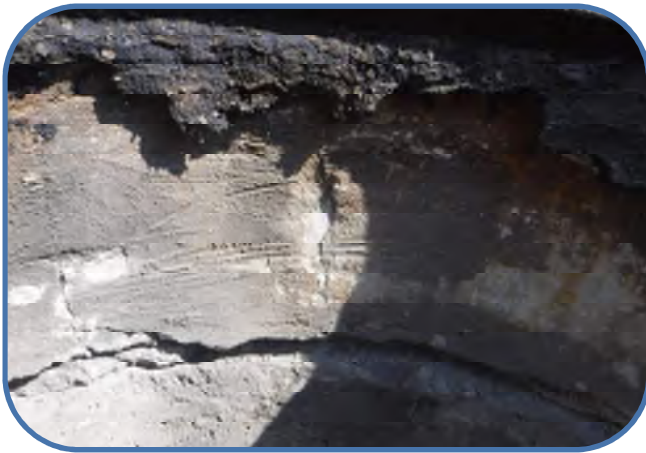
cracked chimney

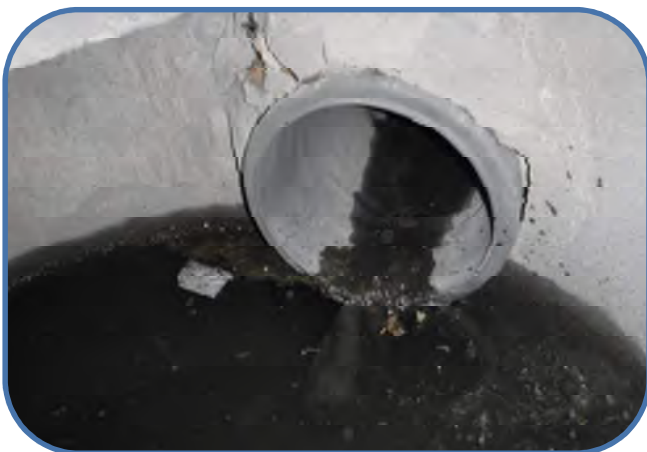
Effluent Pipe Connection: 4-inch protrusion grout is grade score of 3. Grout cracked on effluent see photos

grout cracked on effluent pipe

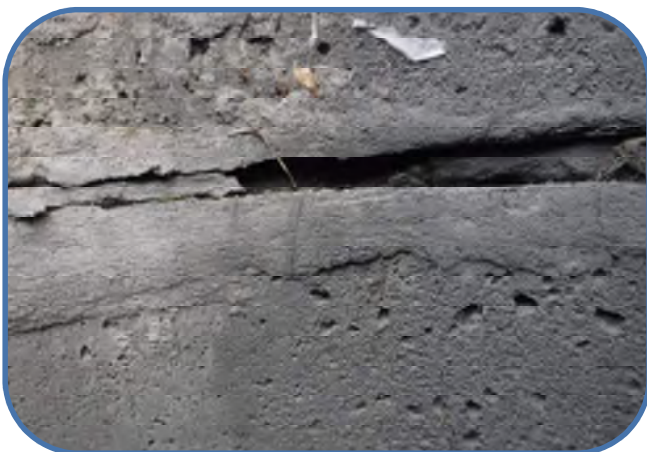
grout cracked between risers

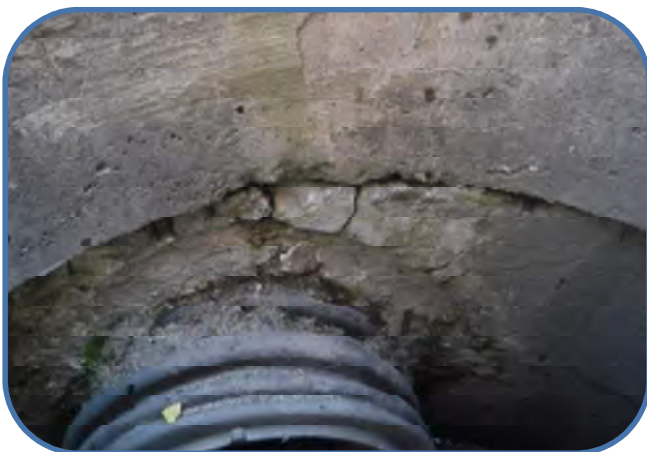
effluent cracked grout

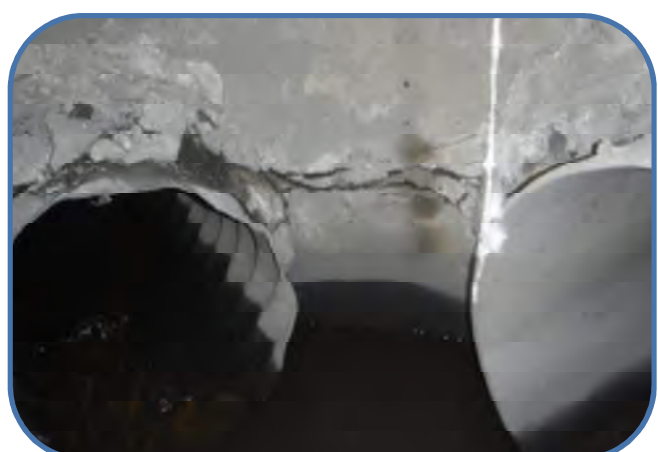
effluent pipe and crack in base

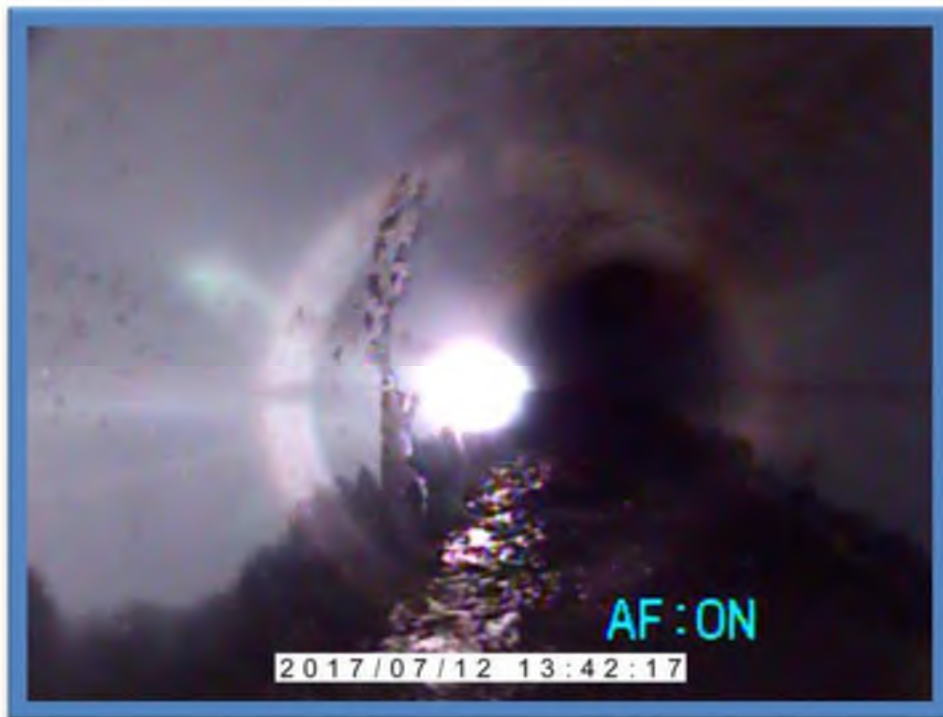
- Hole in pipe at 8 o'clock position. See photo 4.
- Root infiltration between 11 o'clock and 1 o'clock position. See photo 5.

Photo 1-Hole in pipe

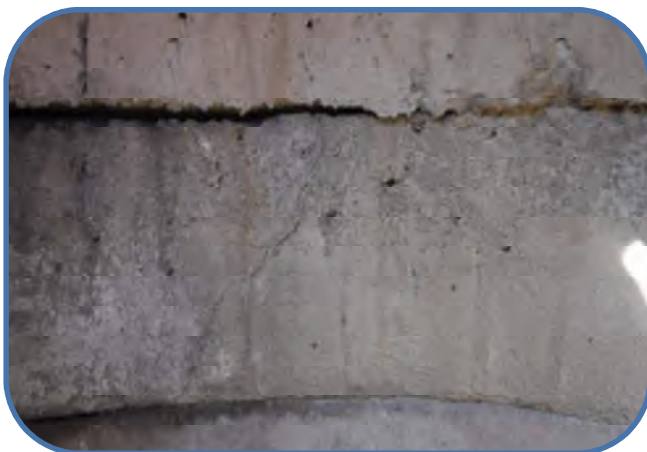
Influent Pipe Connection: Influent pipe connection grout is flaking and missing grout, protrudes 3 inches, grade score of 2.

influent with cracked grout

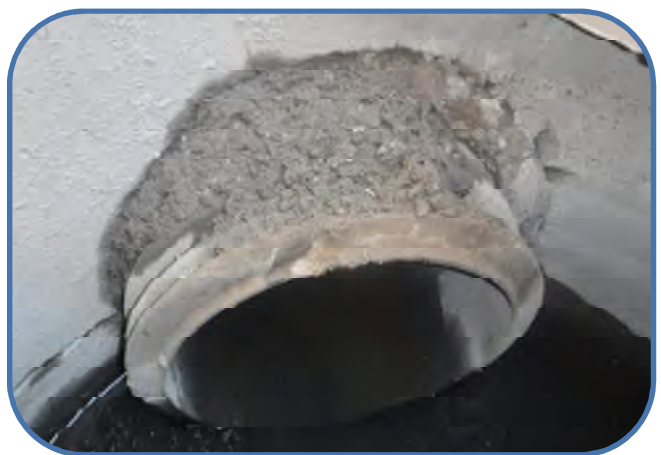
Influent Pipe Connection: Influent pipe connection is grouted but grout is flaking and missing, pipe 1 protrudes 6 -inches, pipe 2 and 4 protrude 2 inches, grade score of 4.

18-inch influent grout missing soil visible

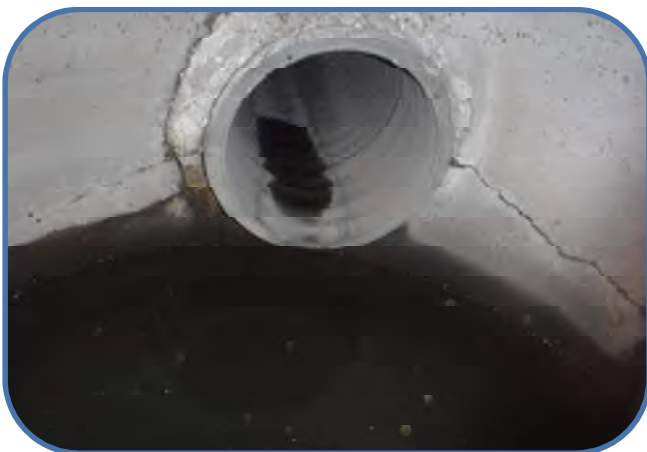
influent 12-inch pipe cracked

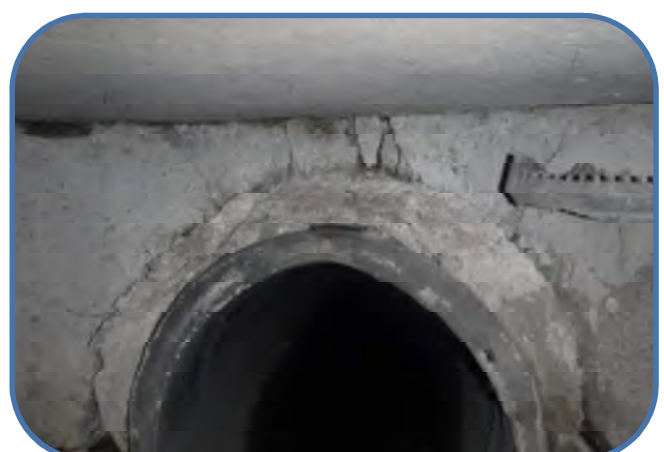
effluent 18-inch pipe cracked
