Draft Geotechnical Data Review

October 2, 2017

**RE: GEOTECHNICAL DATA REVIEW, MIDTOWN CORRIDOR IMPROVEMENTS WEST 32<sup>ND</sup> AND EAST 33<sup>RD</sup> AVENUES BETWEEN ARCTIC BOULEVARD AND OLD SEWARD HIGHWAY, ANCHORAGE, ALASKA**

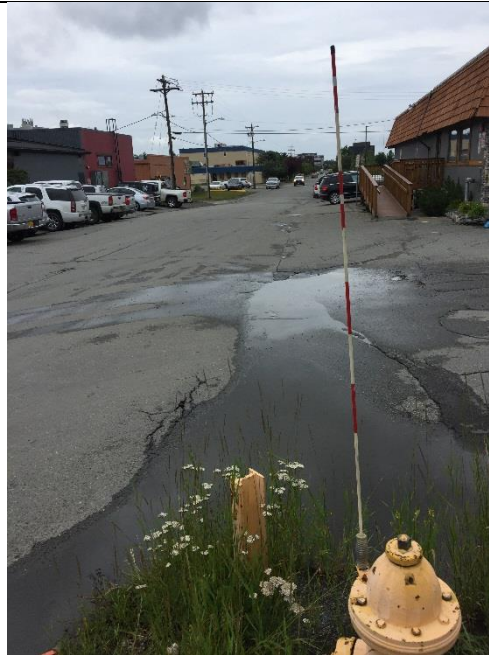
**PHOTO 1**

View looking west from the intersection of the Old Seward Highway and East 33<sup>rd</sup> Avenue.

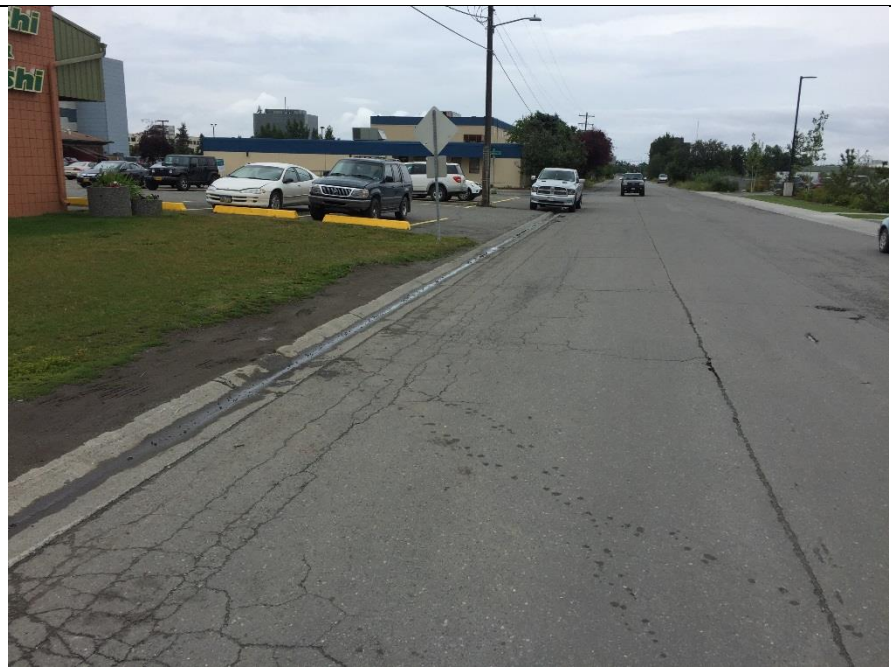
**PHOTO 2**

View west along East 33<sup>rd</sup> Avenue

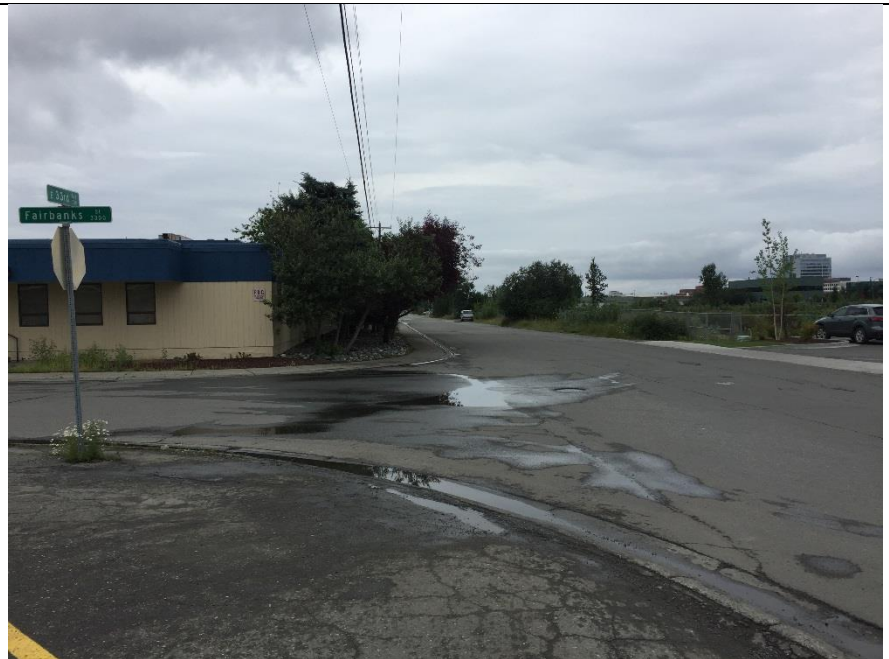
**PHOTO 3**

Intersection of East 33<sup>rd</sup>  
Avenue and Fairbanks  
Street.

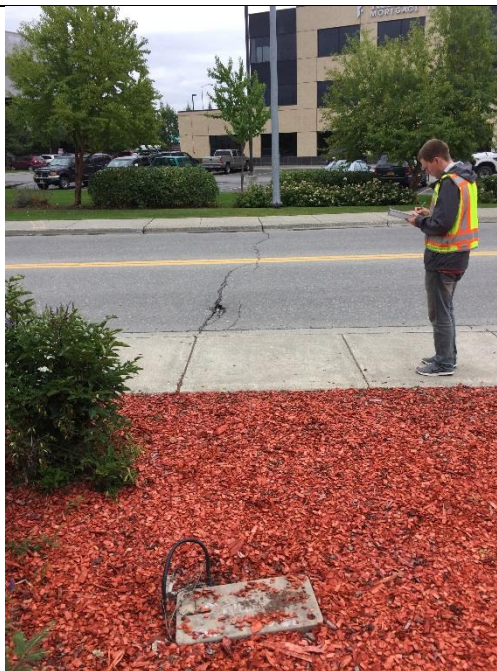
**PHOTO 4**

Longitudinal crack across  
Calais Drive.

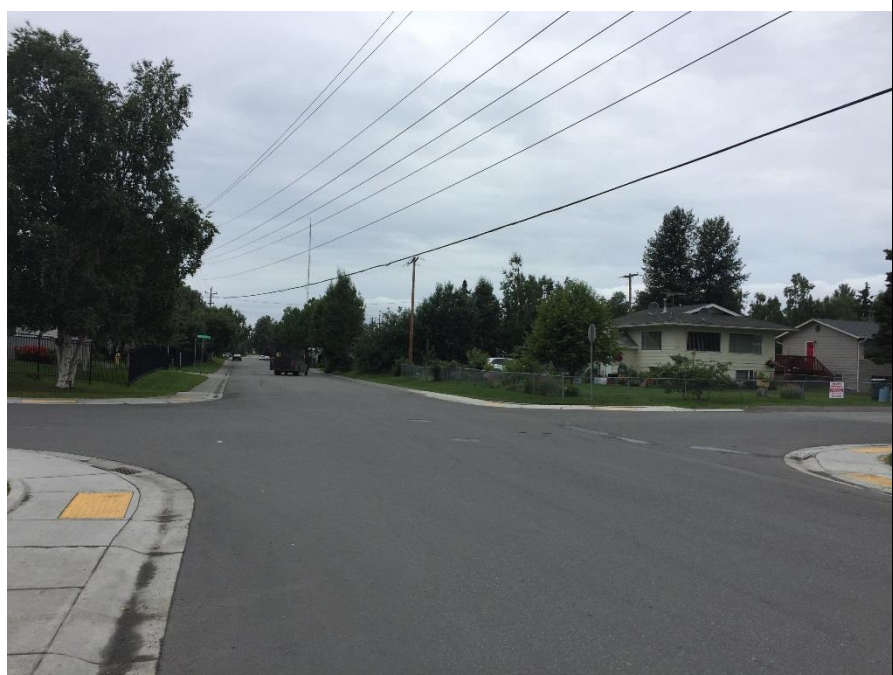
**PHOTO 5**

Recently resurfaced section of West 32<sup>nd</sup> Avenue near Eureka Street.

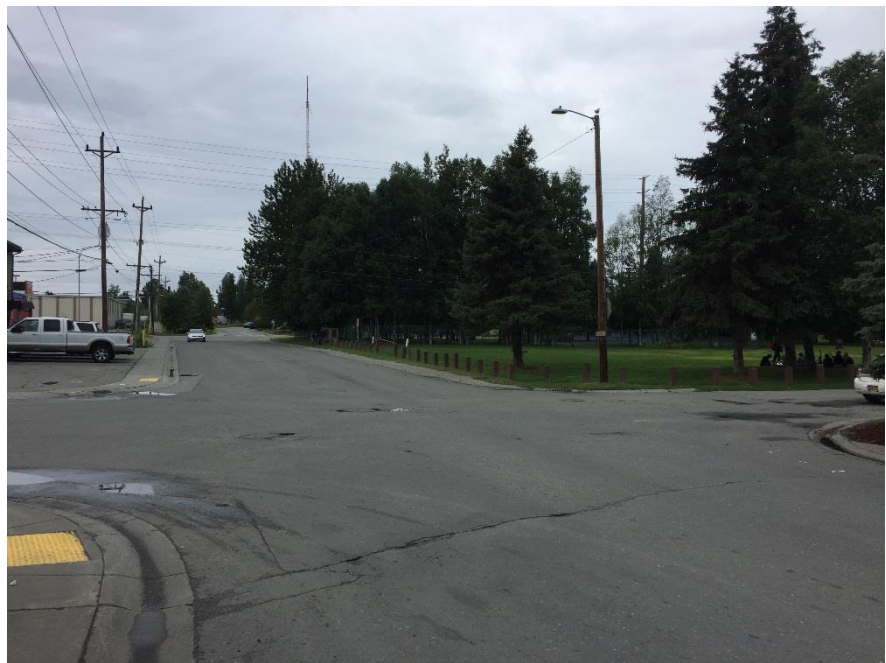
**PHOTO 6**

32 <sup>nd</sup> Avenue and Bering Street - Intersection	<ul style="list-style-type: none"> <li>■ Poor drainage near storm drain inlets, curb rolling</li> </ul>

Intersection of West 32<sup>nd</sup> Avenue and Bering Street.
