Storm Drain Condition Assessment Report

W 32nd AVENUE and E. 33rd AVENUE UPGRADES

STORM DRAIN CONDITION ASSESSMENT

AUGUST 2017

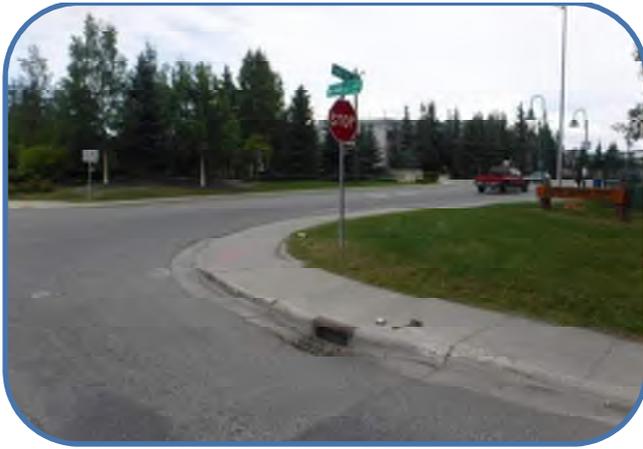
MH 1630-048 looking northwest

Effluent Pipe Connection: 3-inch protrusion grout is flaking grade score of 2

Additional Comment: 12-inch effluent pipe is clogged with debris. Surface corrosion on frame and cover

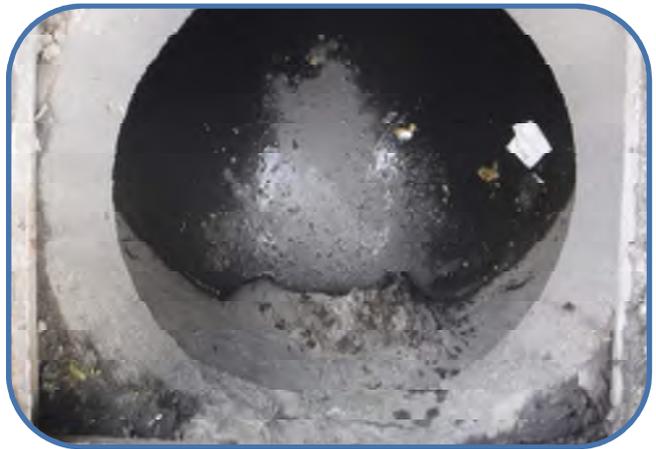
effluent pipe

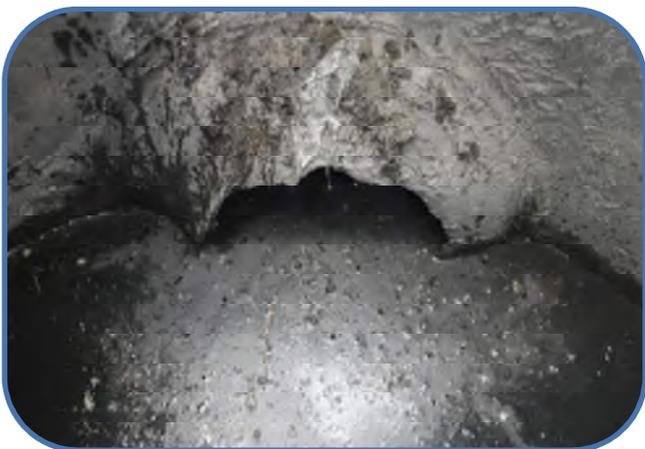
12-inch effluent

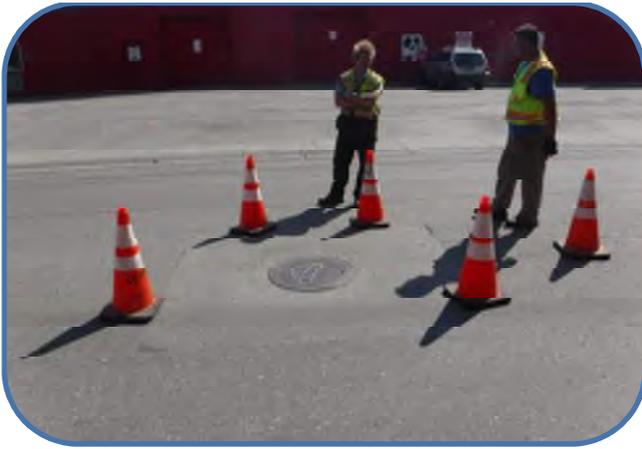
MH 1631-049 looking south towards Mattress Ranch

Additional Comment: frame is offset from chimney, inverts were probed on manhole and all were soft.

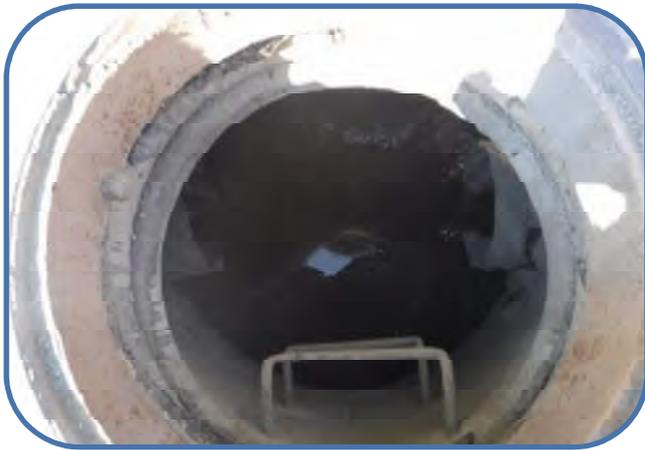
offset frame 1-inch from chimney

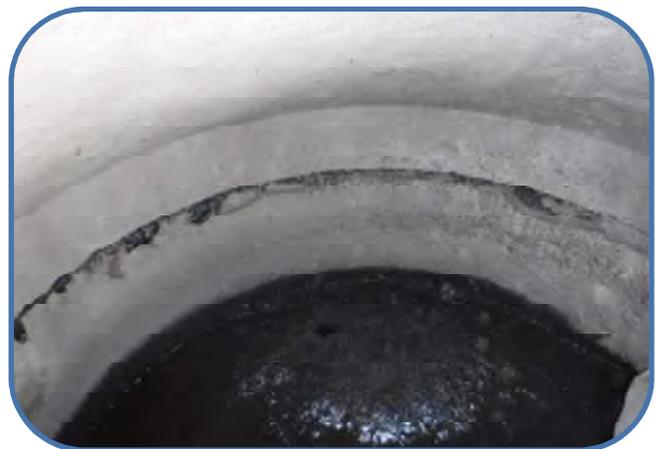
base to cone connection

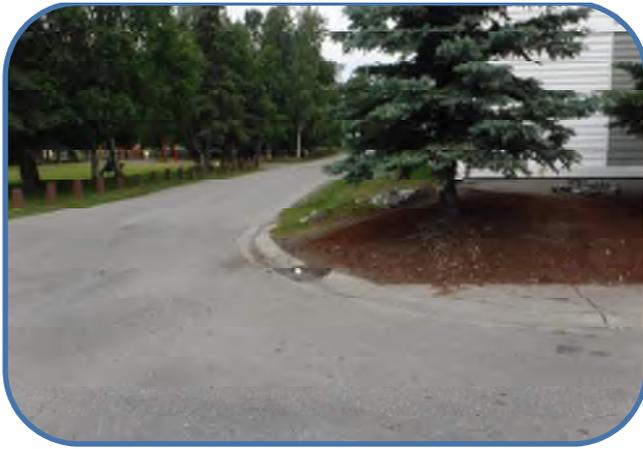
MH 1630-051 looking north

Effluent Pipe Connection: 5-inch protrusion grout is flaking, grade score of 3

Additional Comment: Frame offset from reducing slab 1-inch

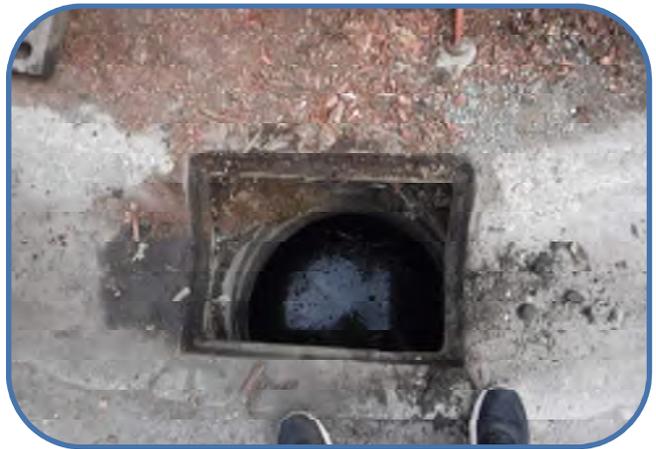
offset frame

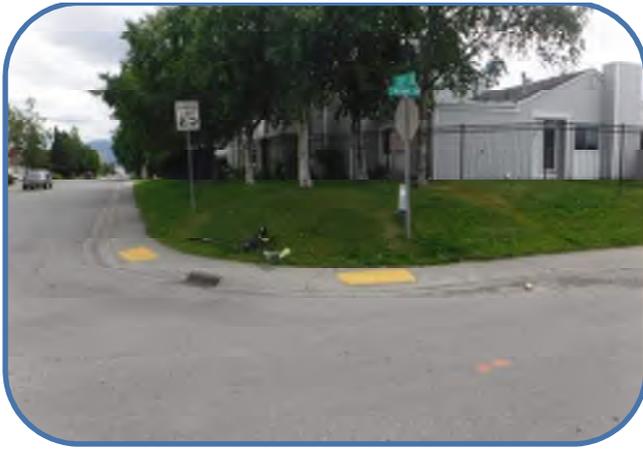
MH 1630-052 looking east

Effluent Pipe Connection: 7-inch protrusion no grout grade score of 4.

Additional Comment: invert was soft when probed with moderate force within manhole

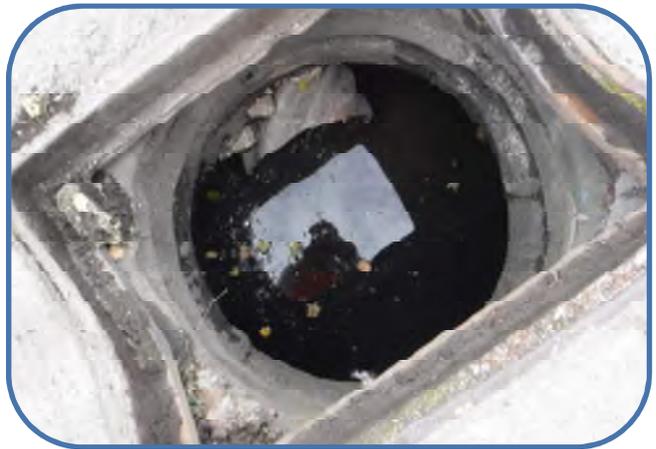
effluent pipe

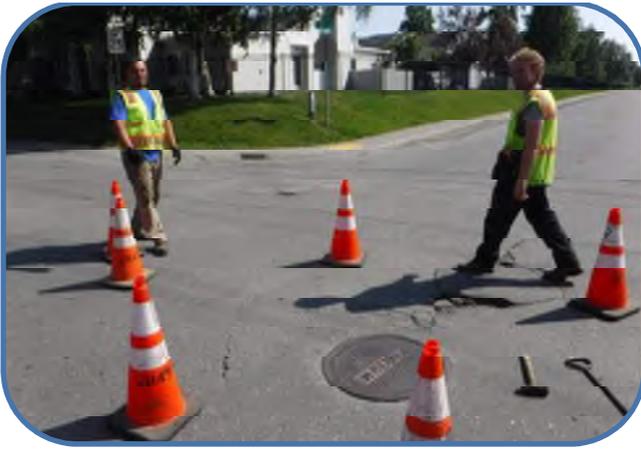
MH 1631-052 looking north

Additional Comment: frame is offset from chimney, inverts were probed on manhole and all were soft.

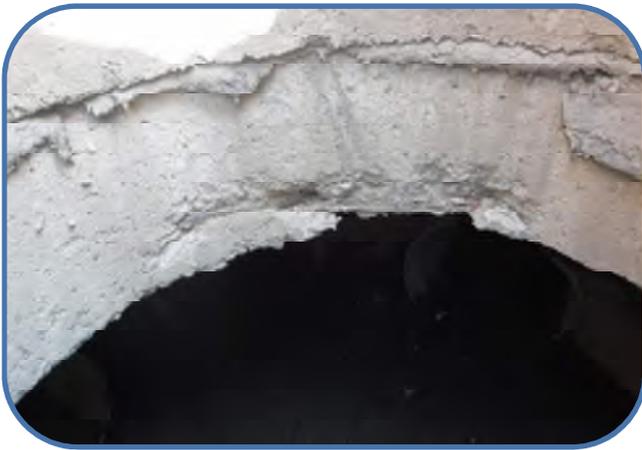
reinforcement exposed in reducing slab

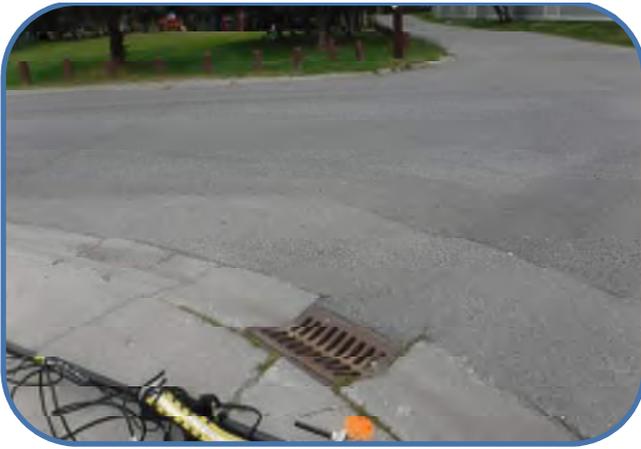
MH 1630-053 looking north

Effluent Pipe Connection: 7-inch protrusion no grout with a grade score of 4.

Additional Comment: frame and cover have corrosion that is leading to minor metal loss

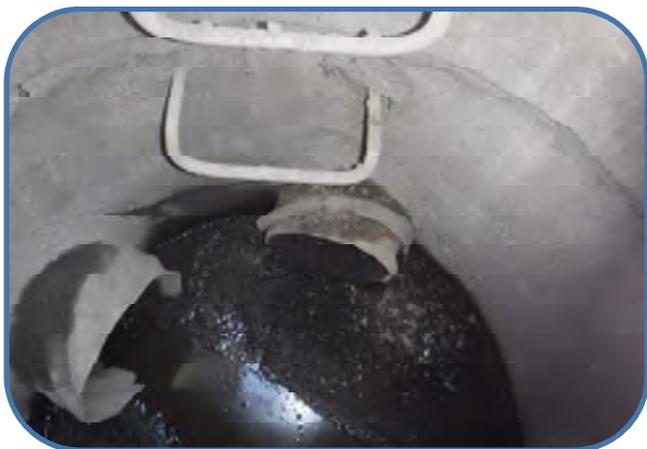
pipe 3 influent sump full of debris

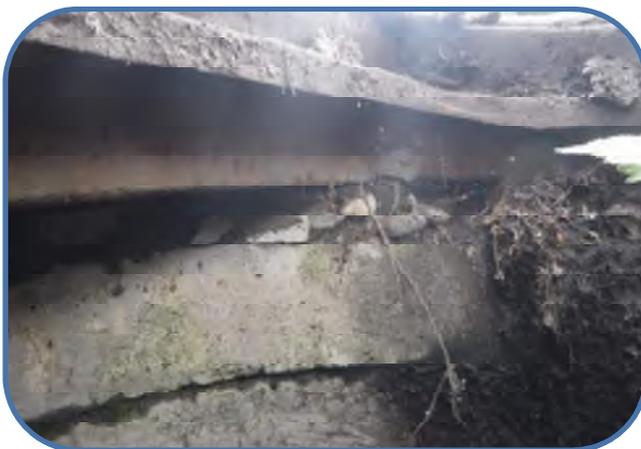
gap between chimney and frame

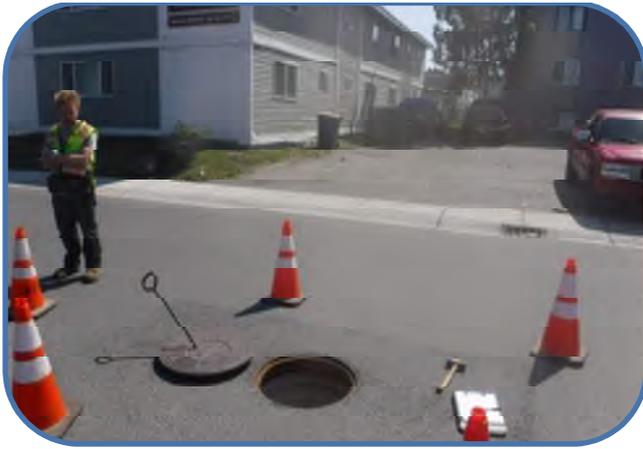
MH 1631-061 looking south

Additional Comment: manhole appears to be newly installed.

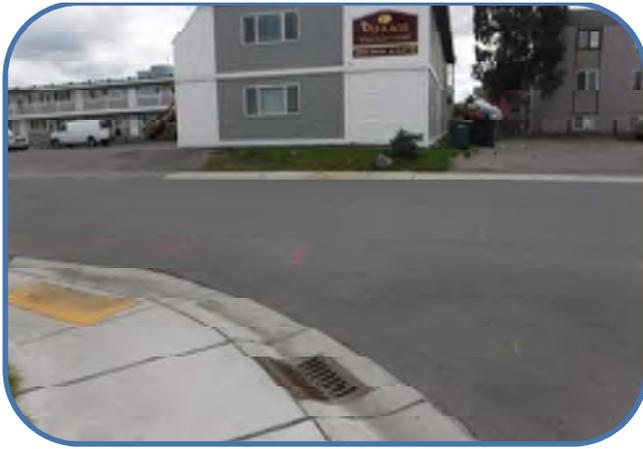
MH 1630-062 looking south

Additional Comment: Manhole in good condition

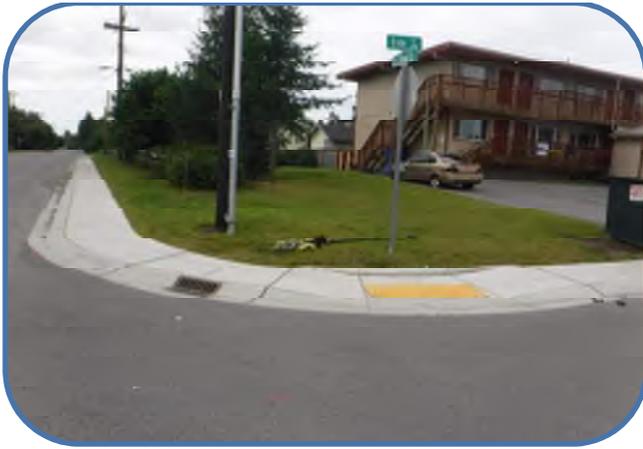
MH 1630-063 looking west

Additional Comment: Manhole in good condition

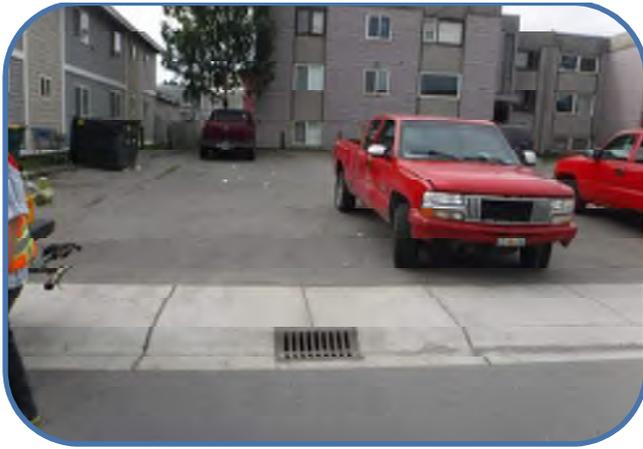
MH 1630-064 looking south

Additional Comment: Manhole in good condition crack above effluent pipe is possibly in grout not base could not determine.

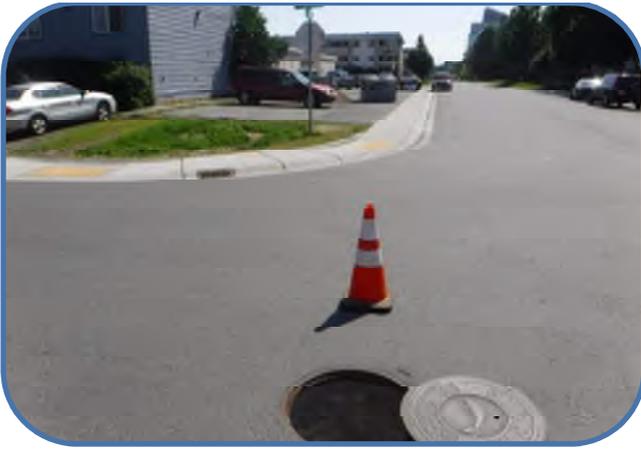
MH 1631-065 looking south

Additional Comment: manhole appears to be newly installed.

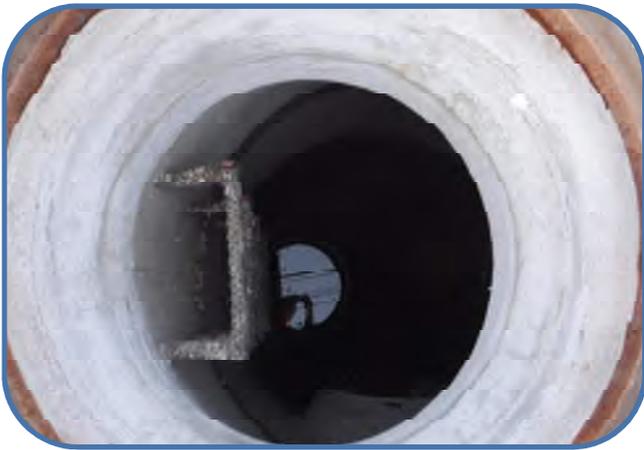
chimney and steps

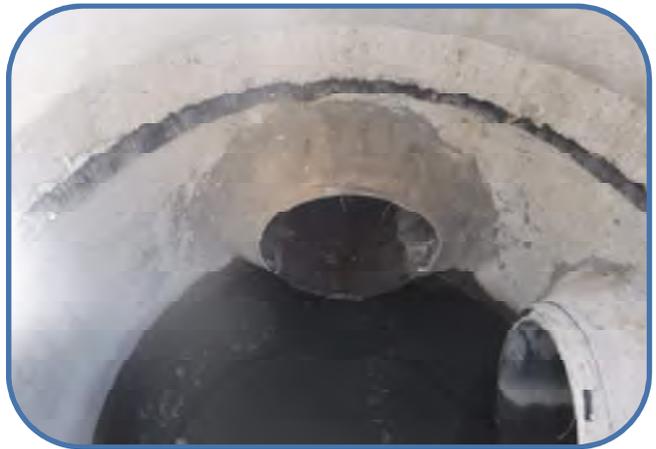
pipe 1 influent

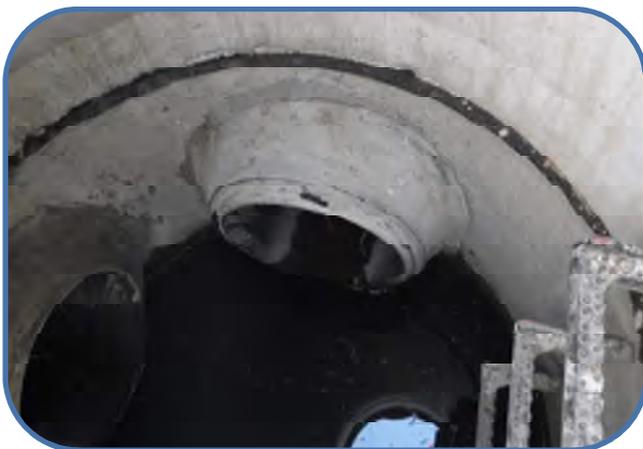
pipe 2 effluent

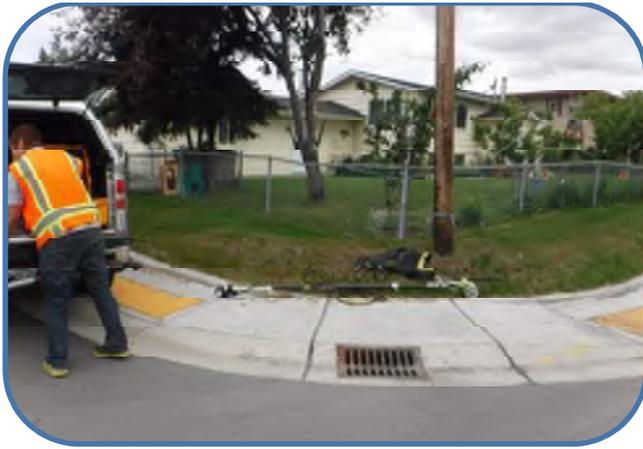
MH 1630-066 looking north

Additional Comment: Manhole in good condition
