32ND AND 33RD Avenue Upgrades

32nd and 33rd Avenue Upgrades

SEWER MANHOLE INSPECTION REPORT

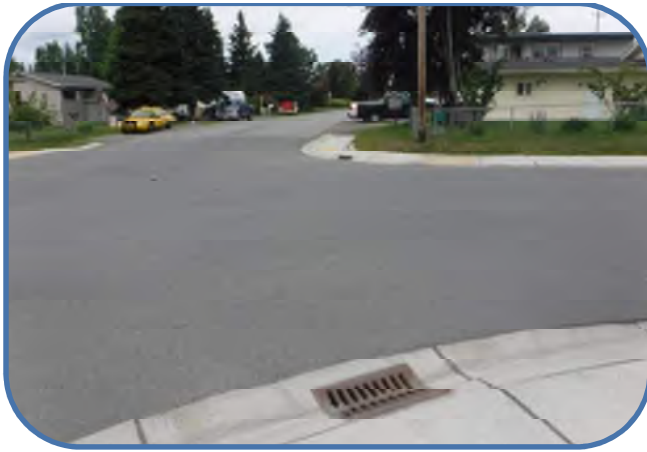
MH 1630-067 looking north

Additional Comment: Manhole in good condition

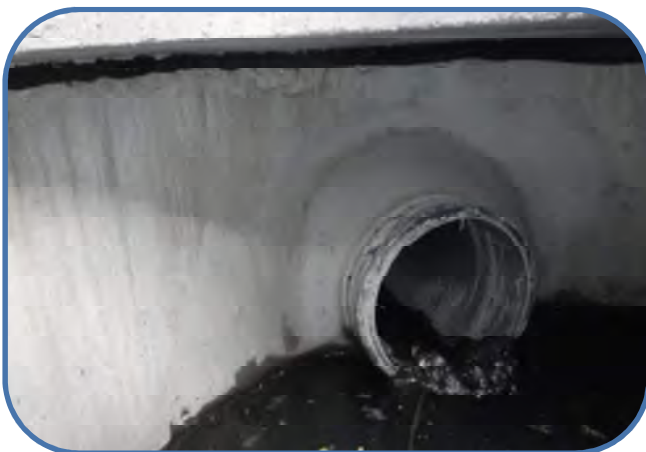
Effluent Pipe Connection: 5-inch protrusion grout grade score of 1.

effluent pipe

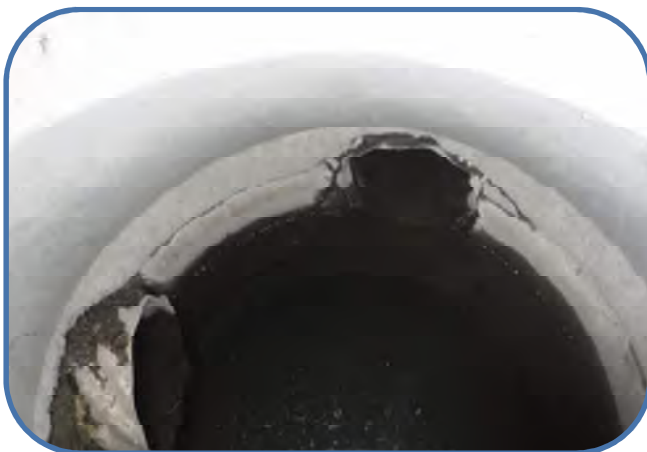
Effluent Pipe Connection: Effluent pipe connection is not grouted, effluent protrudes 6 inches, grade score of 4

influent and effluent 15-inch pipe

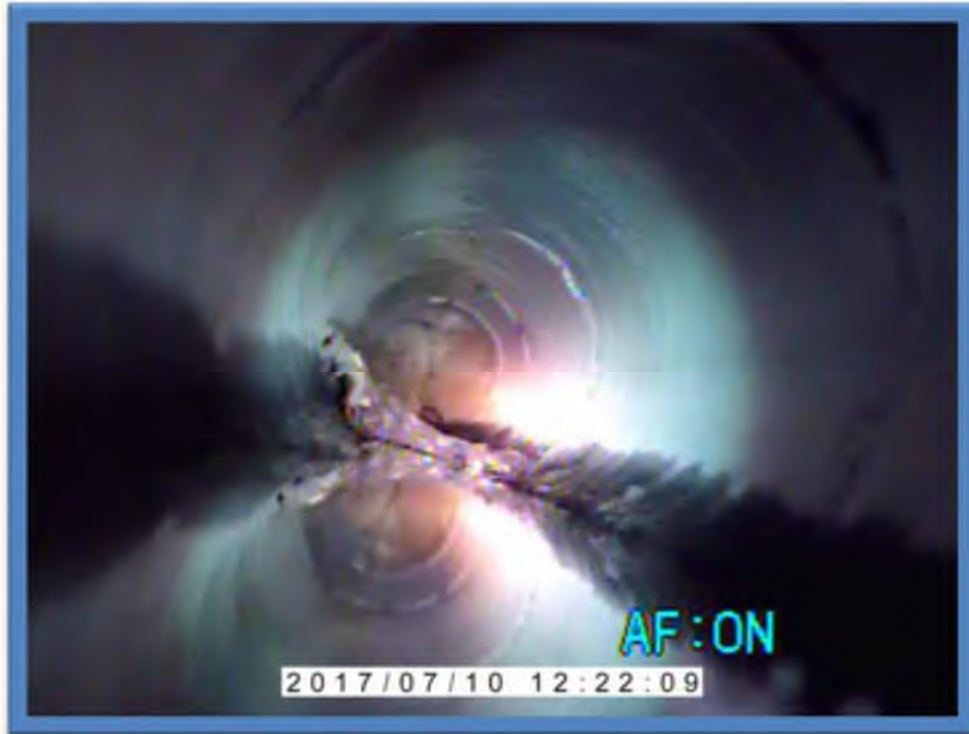
Photo 1-Possible hole in pipe at 8 o'clock with root intrusion.

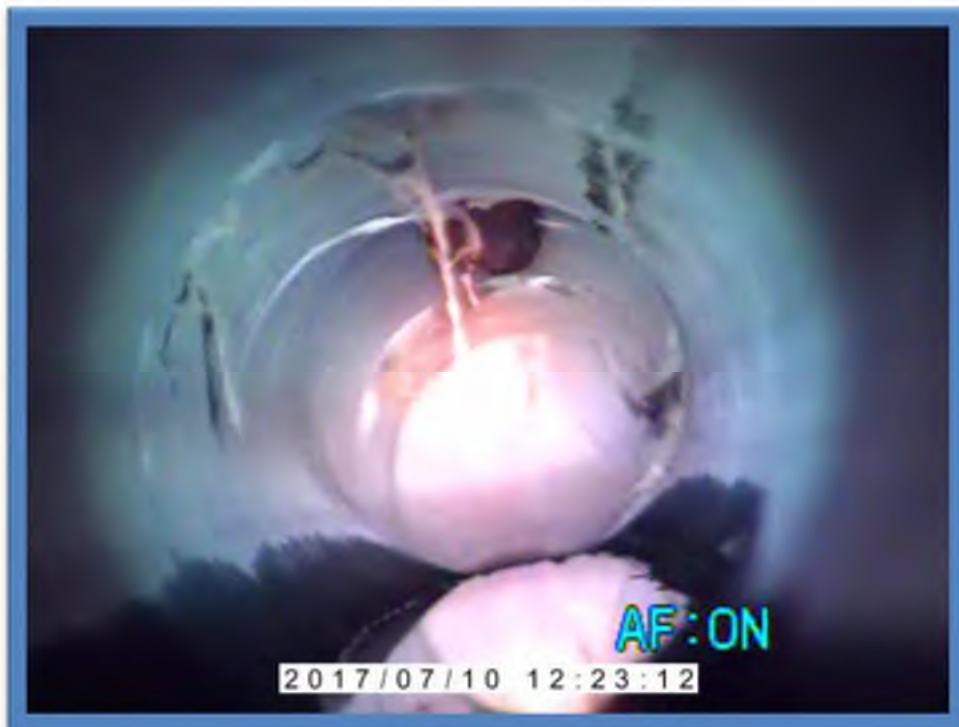
- Root intrusion see photo 2.

Photo 2-Root intrusion at joint within pipe.

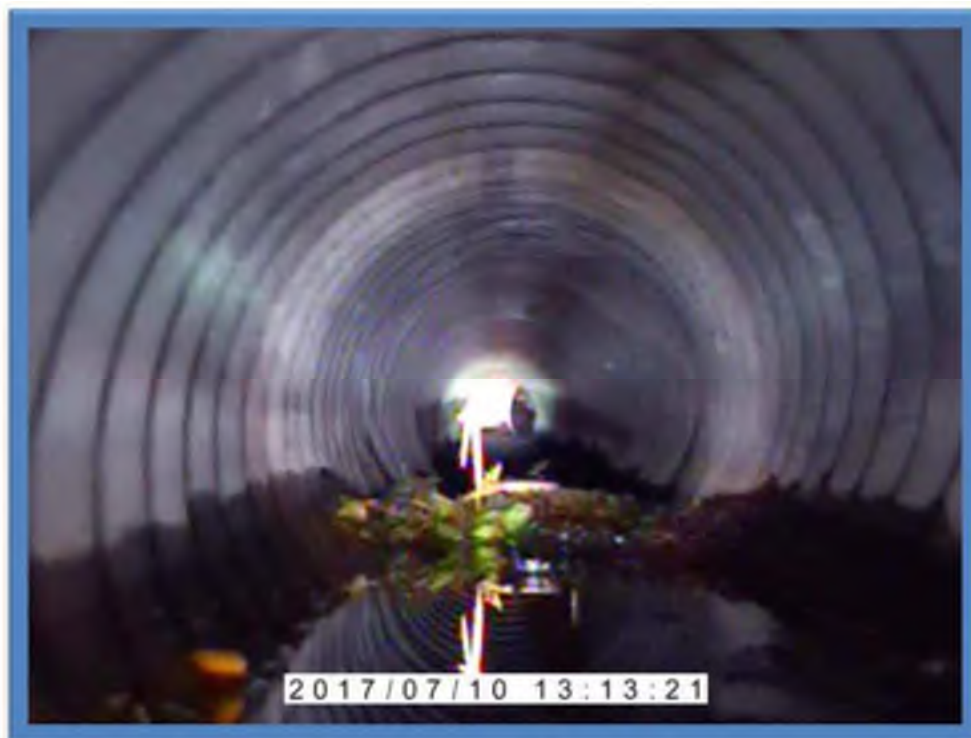
- Up to 4-inches of sediment buildup in invert blocking most of photo (see photo 1)

Photo 1-4 inches of debris in invert blocking flow

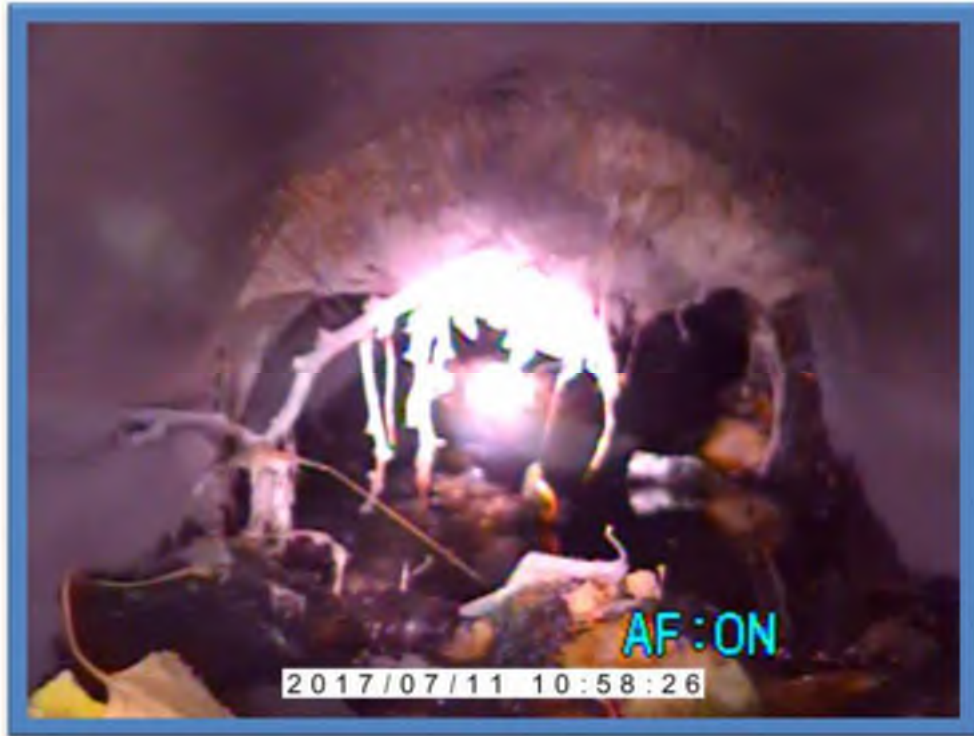
Photo 1-Hole in crown of pipe between 10 o'clock and 2 o'clock position

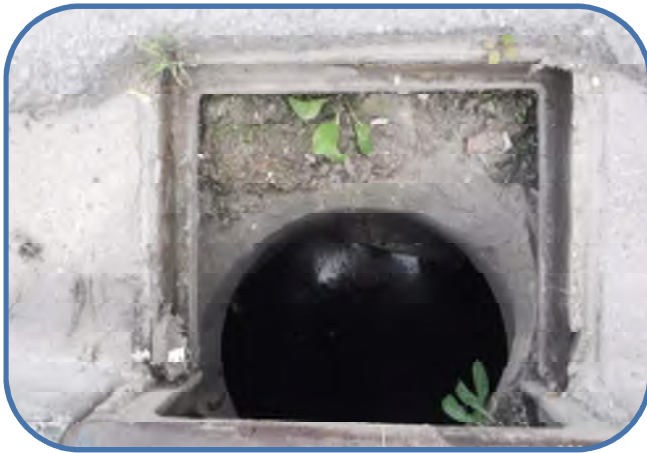
Additional Comment: Soil protruding between frame and chimney. Separation is approx. ½ inch. Frame is offset from chimney and reducing slab approx. 6-inches to the north.

Offset frame from manhole

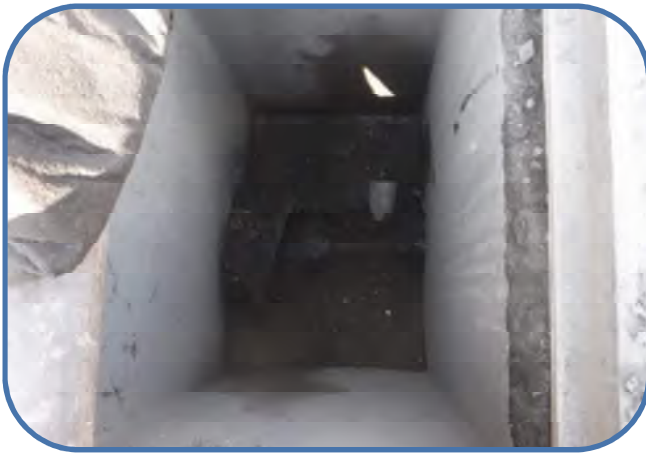
effluent pipe is to the left in photo

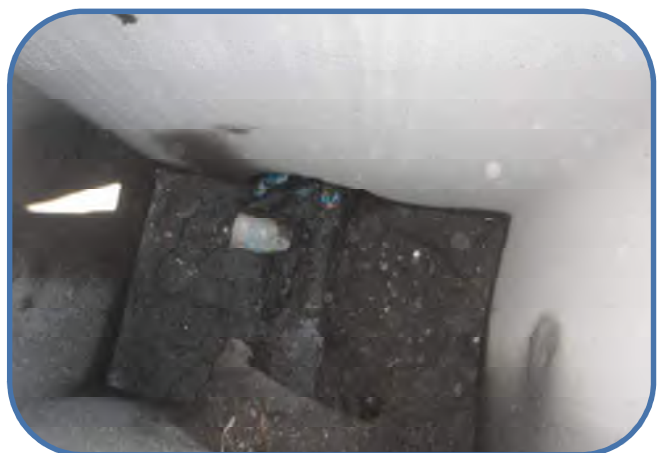
influent pipe is flush

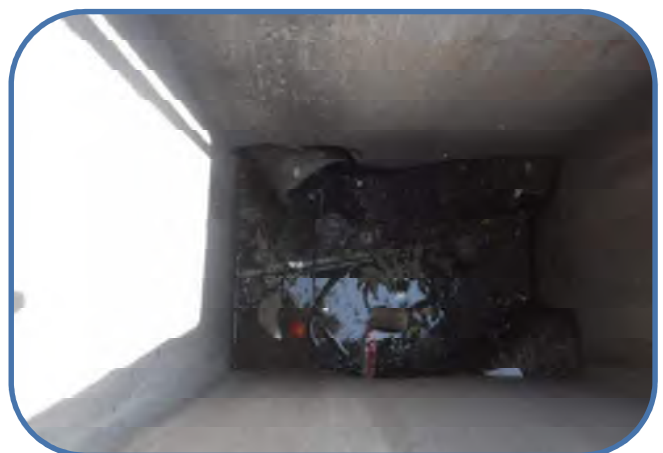
sump full of debris

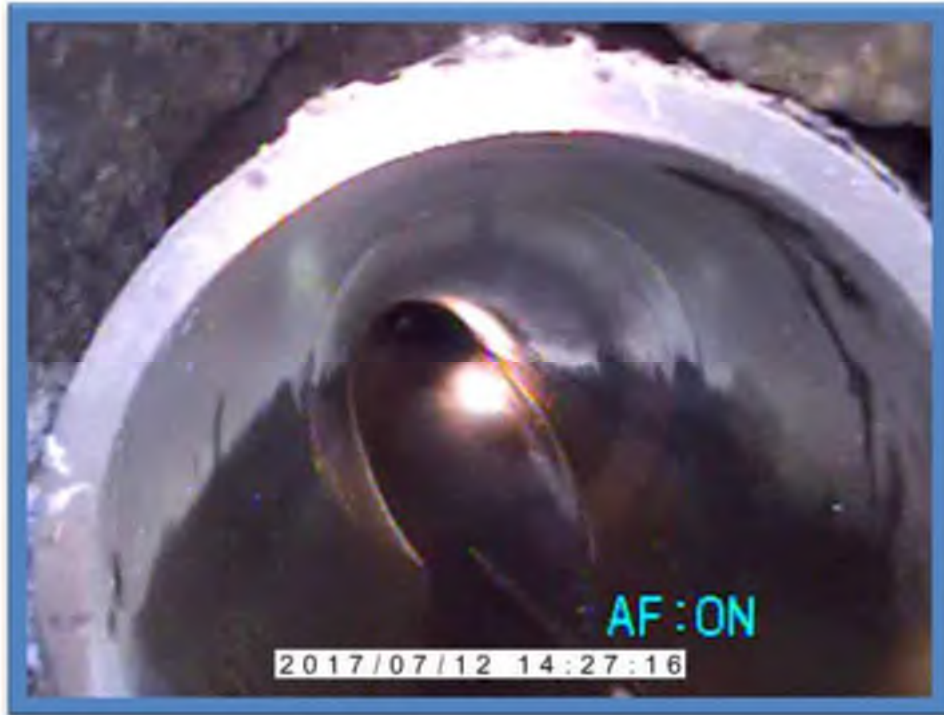
- Very little of pipe inspected due to alignment of pipe into manhole
- Electrical wire on invert of pipe, likely thaw system
- Pipe has potential grade issues, standing water observed in pipe approximately 5 feet to east of MH1630- 204, see photo 1.

Photo 1-Standing water in pipe

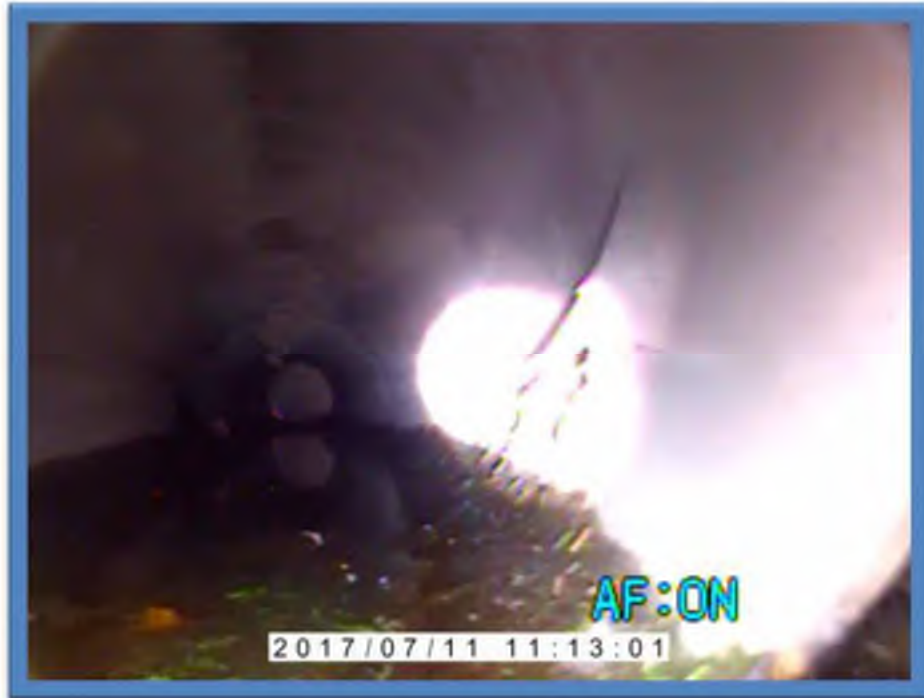
Photo 1-Hole in pipe at 5 o'clock position

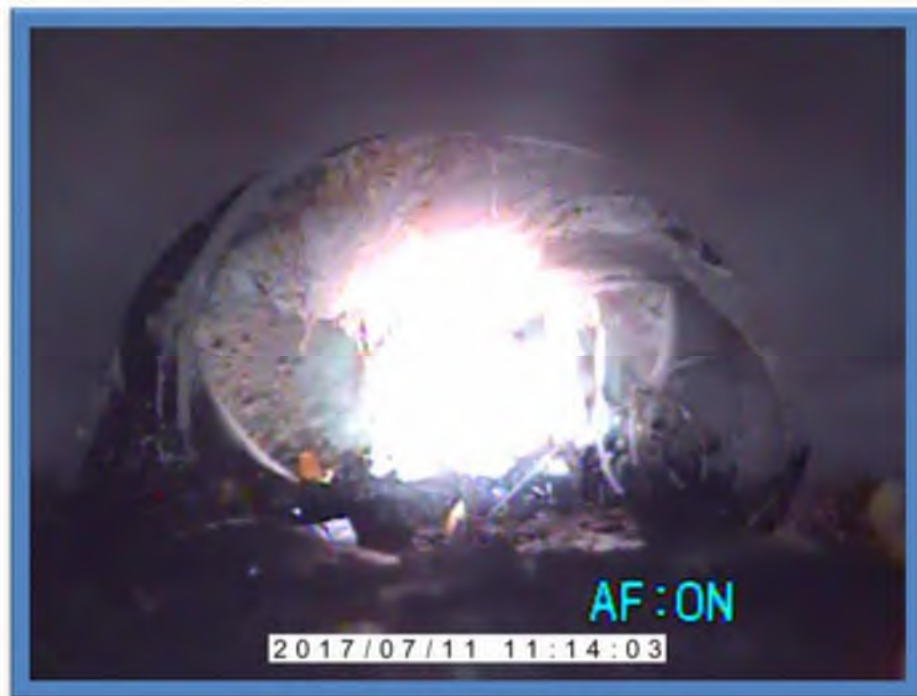
- Hole in pipe/possible collapse (see photo 2)

Photo 2-Pipe collapsing between 7 and 11 o'clock soil void visible behind hole.

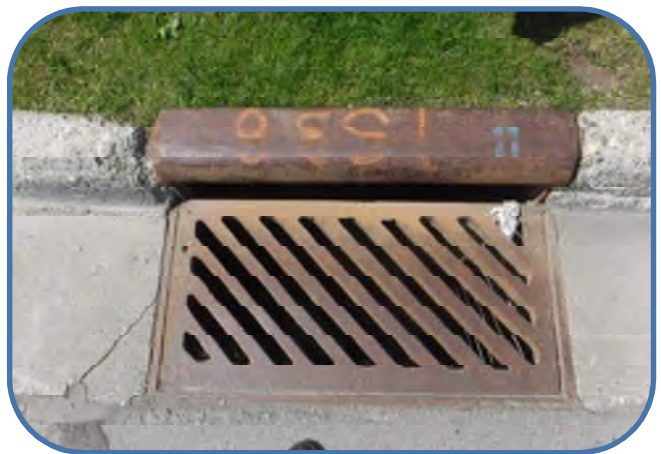
Additional Comment: Pipe is likely a type of fiberglass polymer pipe. Frame is broken on the inlet see photos

mh frame and inlet

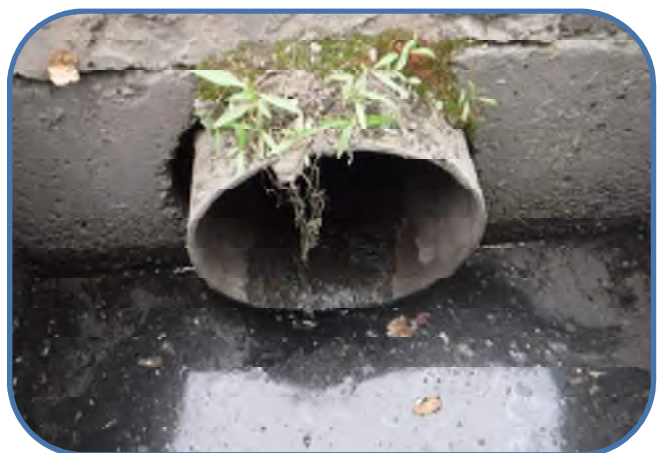
Effluent Pipe Connection: 4-inch protrusion no grout is present grade score of 4.

base and pipe penetration. no grout

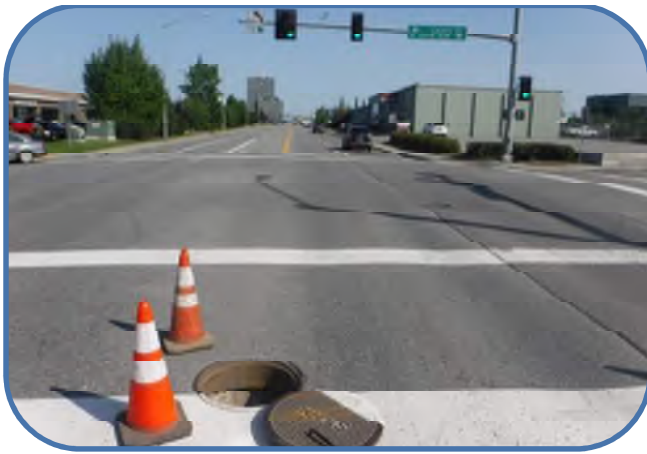
MH 1631-002 looking north

Additional Comment: Grade rings slightly offset

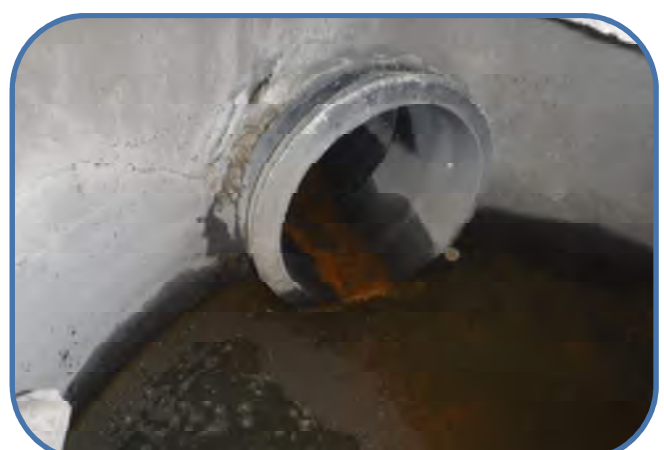
Effluent Pipe Connection: Effluent pipe connection grout is flaking. Effluent protrudes 6 inches. Grade score of 2.

effluent 21-inch pipe

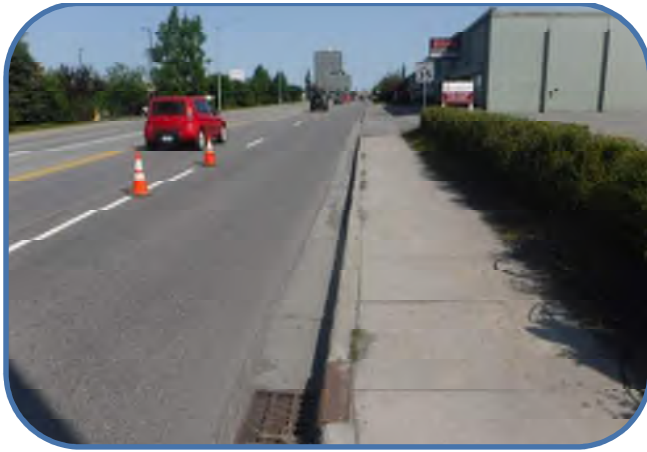
MH 1631-004 looking north

Additional Comment: slight crack

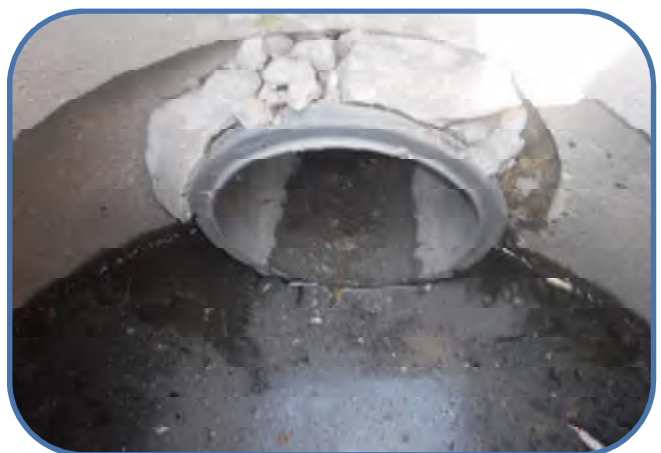
Effluent Pipe Connection: Effluent pipe connection grout is flaking and missing grout, effluent protrudes 3 inches, grade score of 4.

12-inch effluent

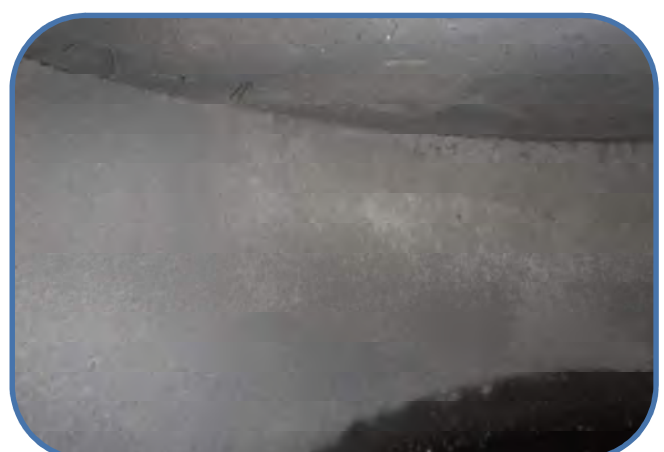
manhole base and reducing slab

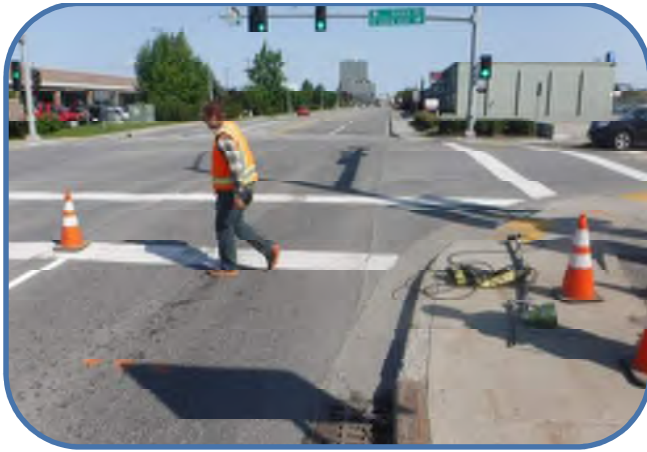
MH 1631-005 looking north

Additional Comment: Grade rings slightly offset

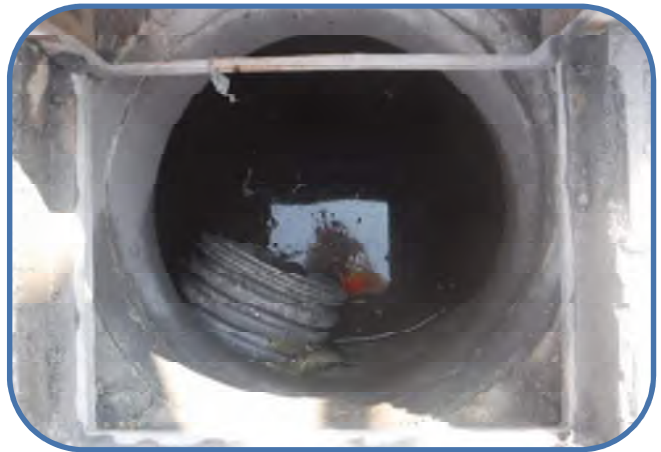
Effluent Pipe Connection: Effluent pipe connection grout is flaking and missing grout, effluent protrudes 6-inches, grade score of 3.

12-inch effluent

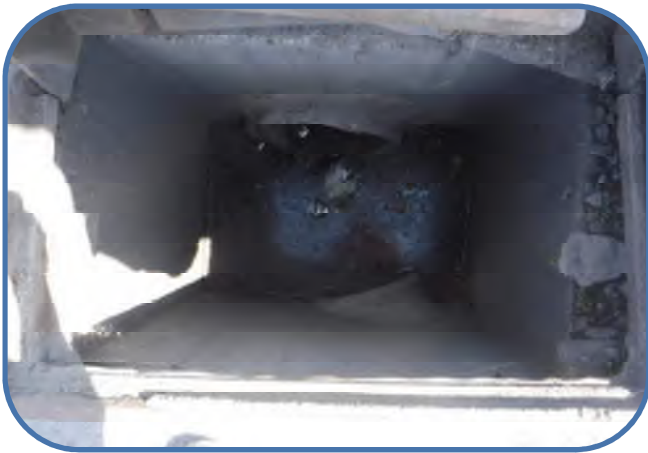
Base: Too much debris with a grade score of 2. Some surface spalling of concrete on base.

mh base

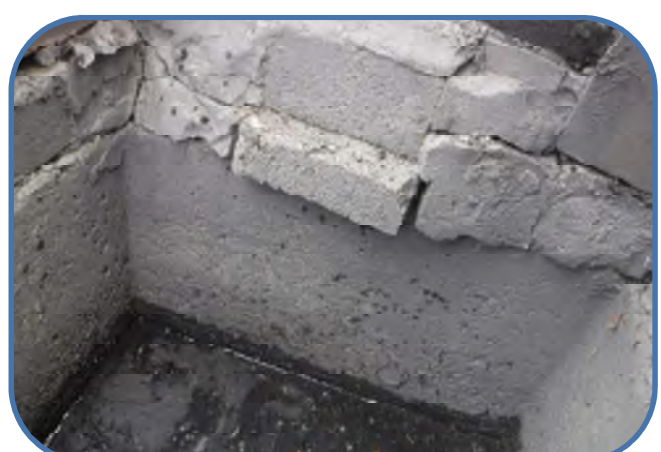
Chimney: Chimney poor condition too difficult to measure height due to the poor condition, grade score of 5

chimney

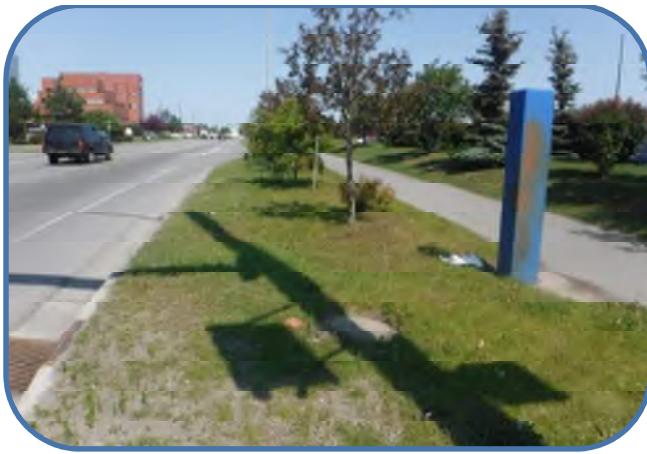
MH 1631-051A looking north

Additional Comment: Chimney is in poor condition, pipe is likely a type of fiberglass polymer pipe

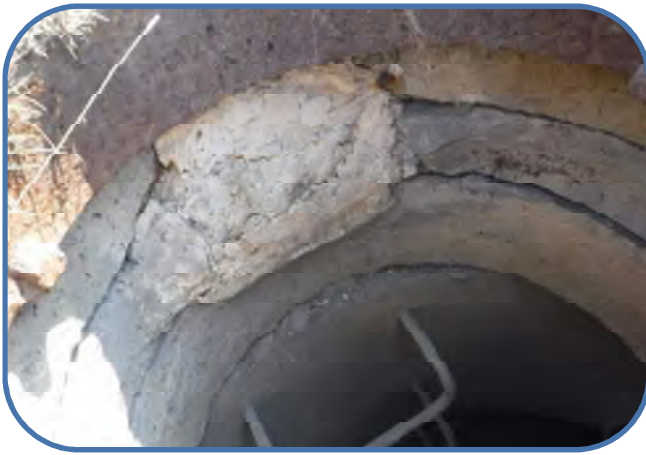
chimney grouting

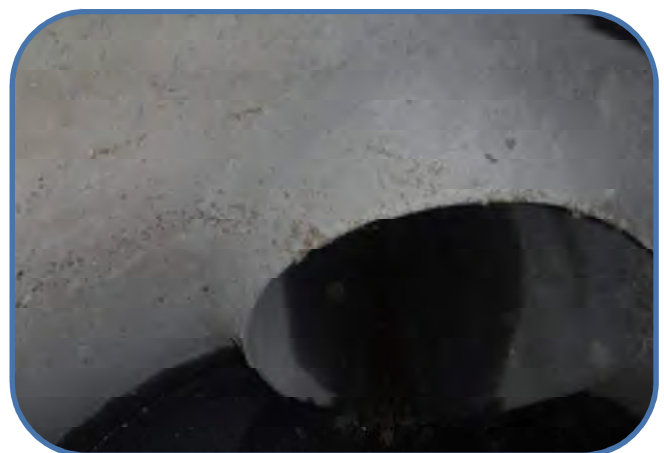
Effluent Pipe Connection: Effluent pipe connection protrudes 3 inches, grade score of 2.

effluent pipe

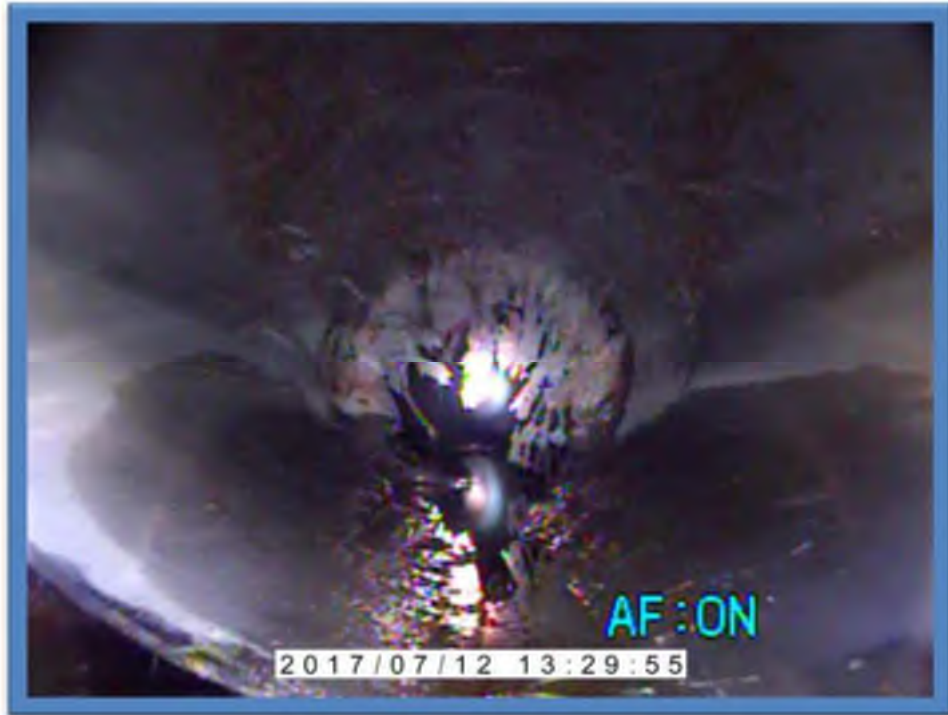
- Pipe damaged between 10 o'clock and 1 o'clock position, see photo 1, root intrusion

Photo 1-Root intrusion in pipe

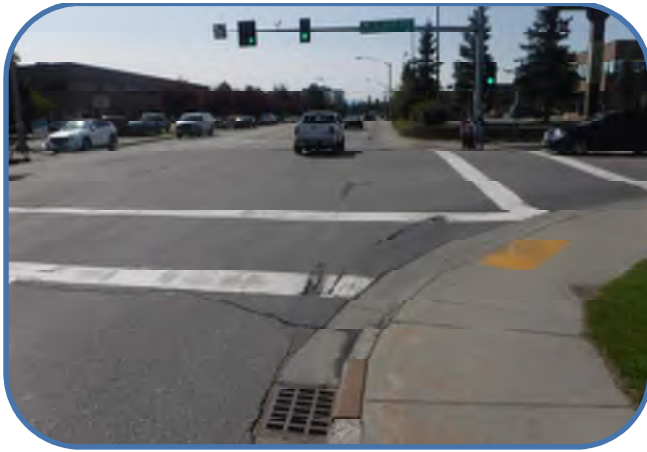
MH 1631-089 looking south

Additional Comment: Grout missing on chimney, cracks in base

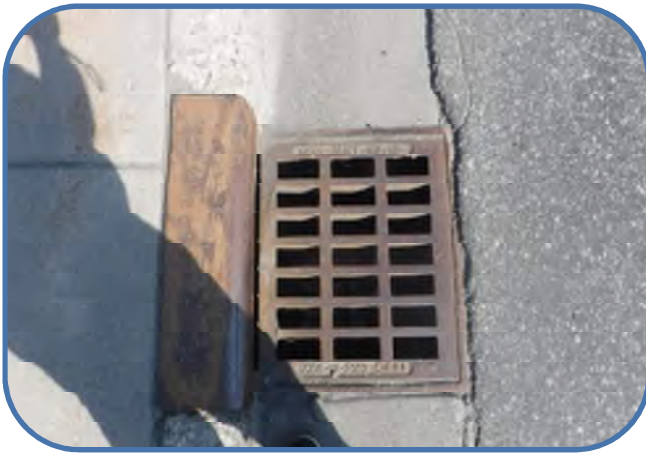
MH frame

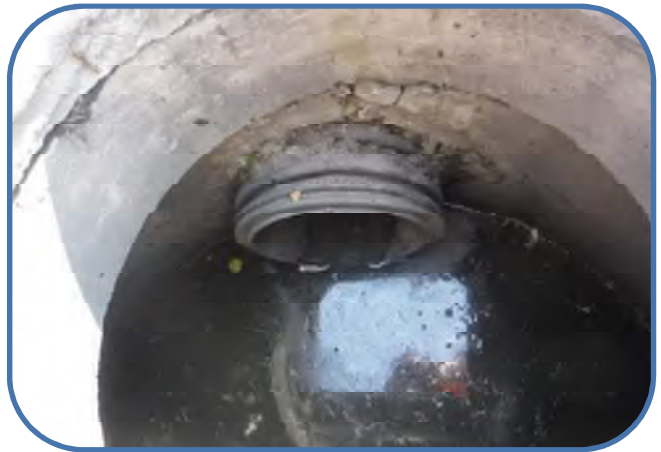
12-inch effluent

Effluent Pipe Connection: Effluent pipe connection grout is flaking and missing grout, effluent protrudes 6 inches, grade score of 3.

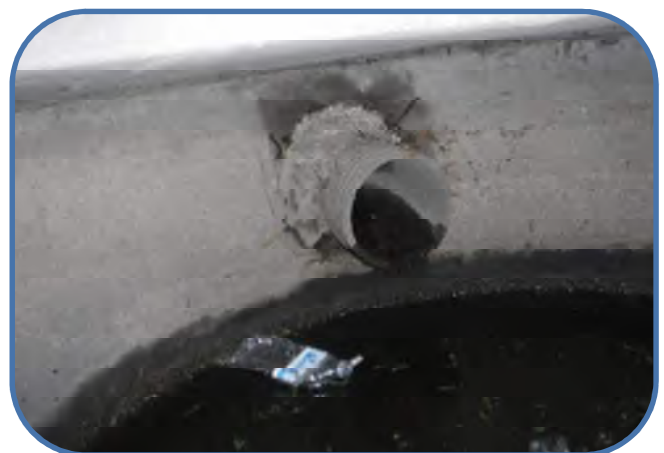
6-inch influent

Influent Pipe Connection: Influent pipe connection grout is flaking and missing grout, protrudes 4 inches, grade score of 4.

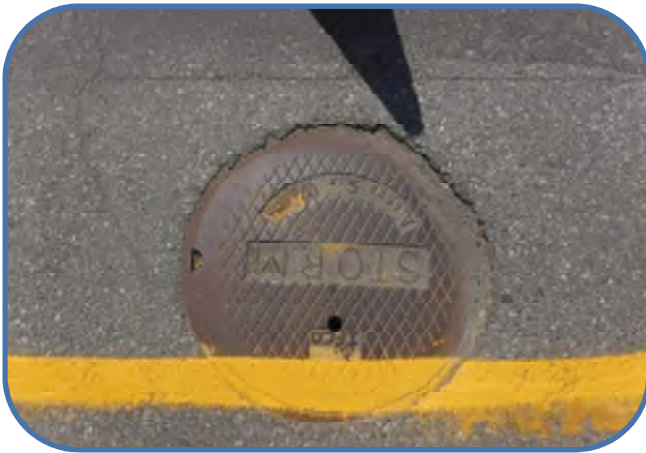
mh cover

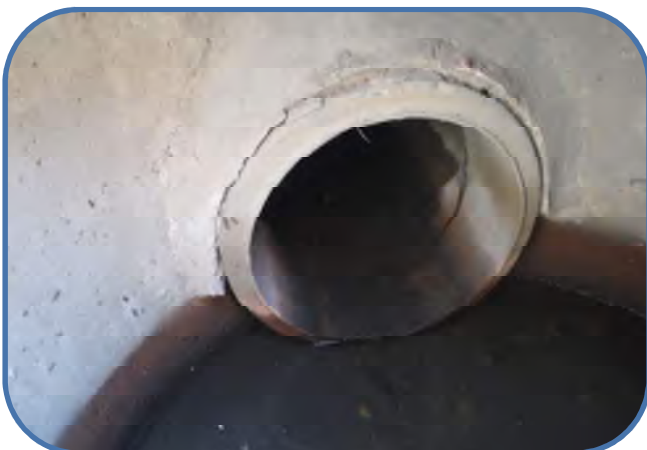
effluent pipe

Effluent Pipe Connection: Effluent pipe connection protrudes 2 inches, grade score of 2.

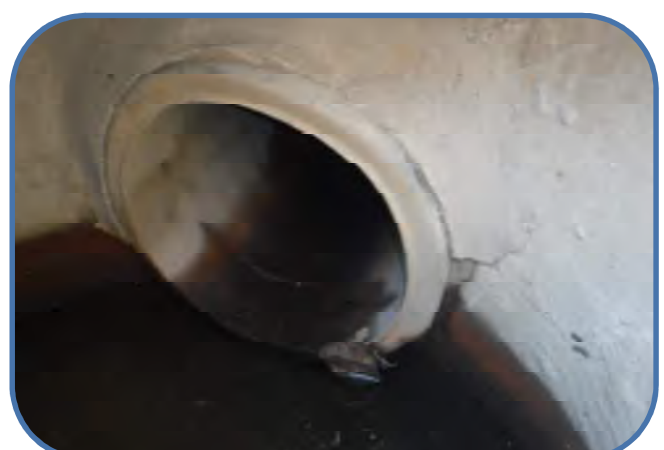
Additional Comment: influent pipe is broken between 11 and 3 o'clock, cracks in chimneys.

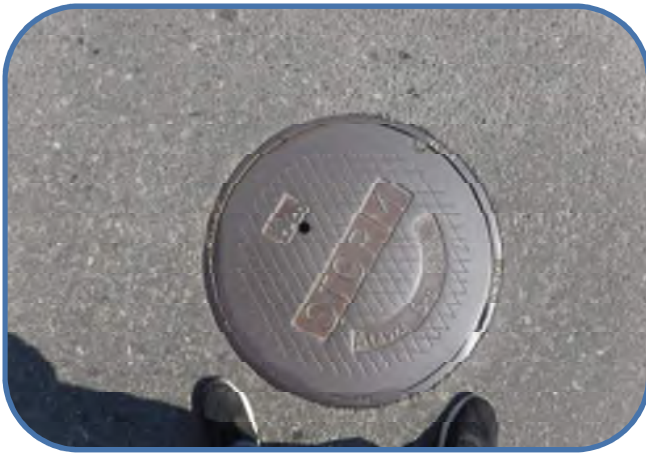
Additional Comment: Small amount of corrosion on frame and steps

MH frame

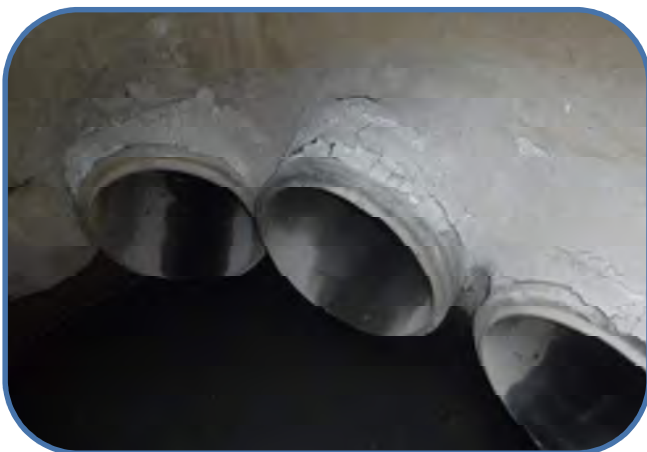
influent pipes

Influent Pipe Connection: Influent pipe connection grout is flaking and missing grout, protrusion varies between 2 and 3 inches, grade score of 3.

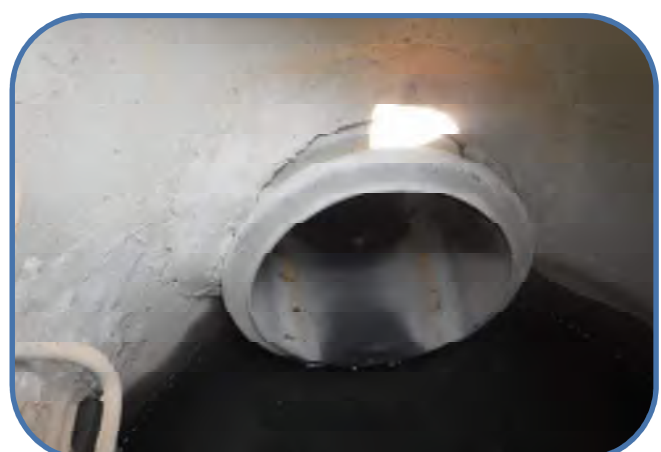
effluent pipe

Effluent Pipe Connection: Effluent pipe connection grout is flaking and missing grout, protrudes 3 inches, grade score of 3.

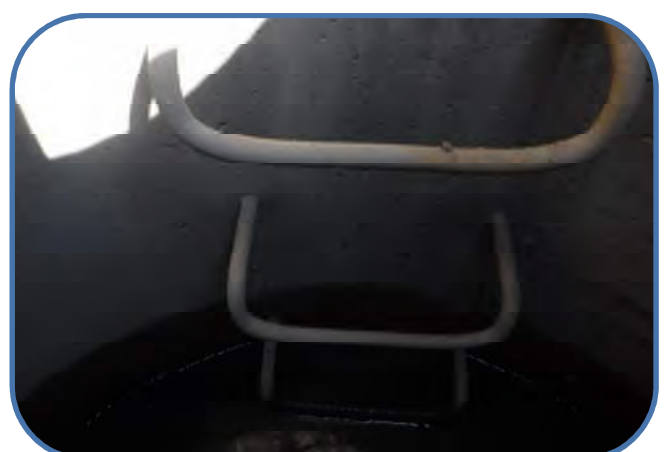
Additional Comment: Small amount of corrosion on frame and steps

metal steps

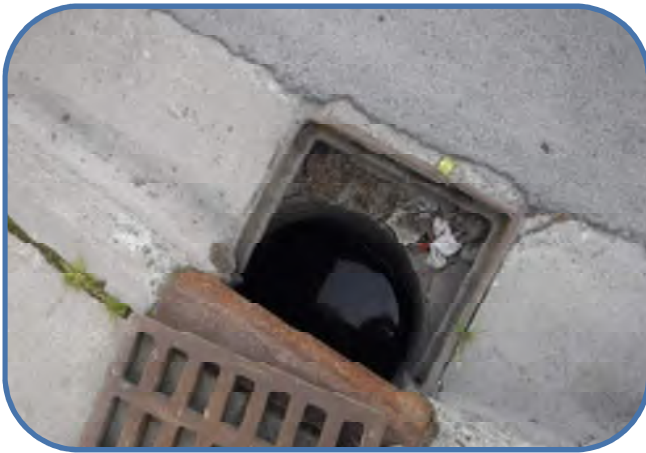
Additional Comment: Frame is offset 5 inches from chimneys see photos

offset frame from riser

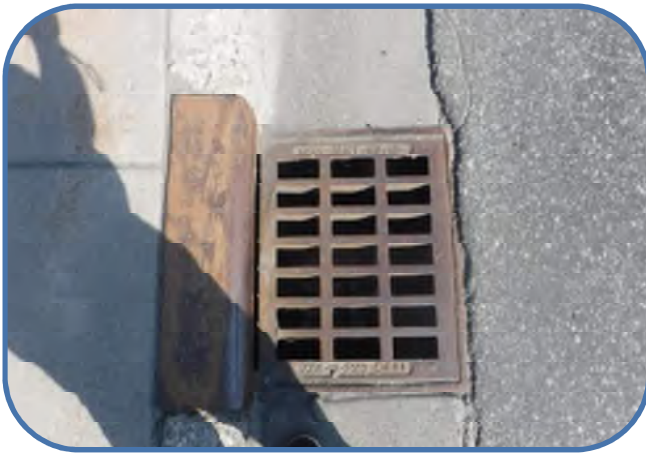
Additional Comment: Missing metal on frame.

MH frame

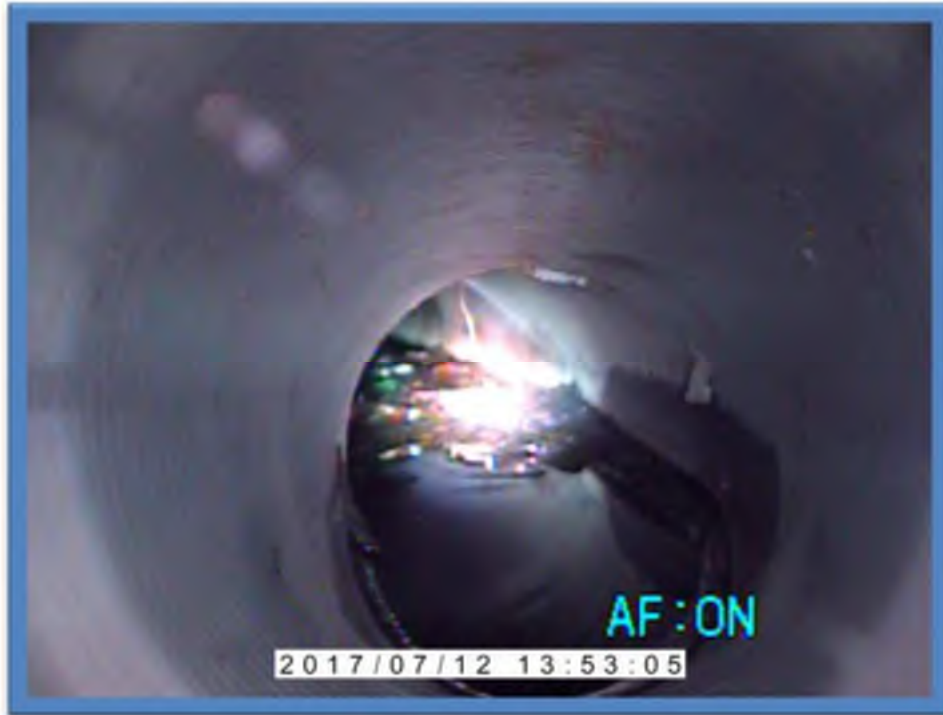
1

- Grade break in pipe.
- Alignment change in pipe. See Photo 1.
- Pipe section ties directly into 18-inch CPEP that runs between MH 1631-132 and 1631-090

Photo 1-Grade break in pipe resulting in debris buildup. Also pipe changes alignment and deflects to the southeast. Pipe section ties directly into 18-inch CPEP pipe.

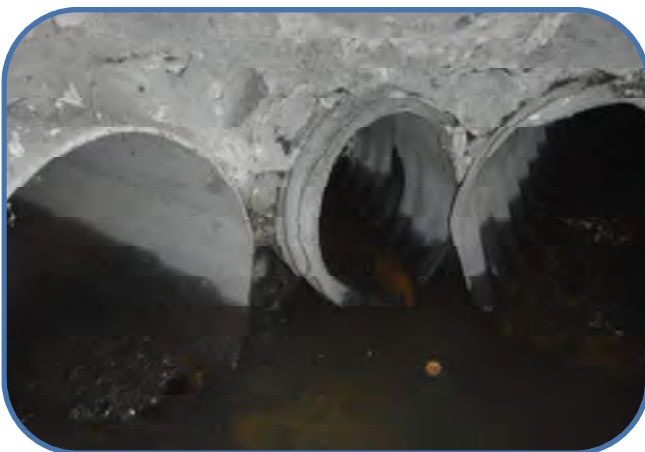
Additional Comment: Pipe 2 runs to northeast. Could not find where it goes to surface.

influent pipes, 12-inch CPEP could not find end on surface or with quickview

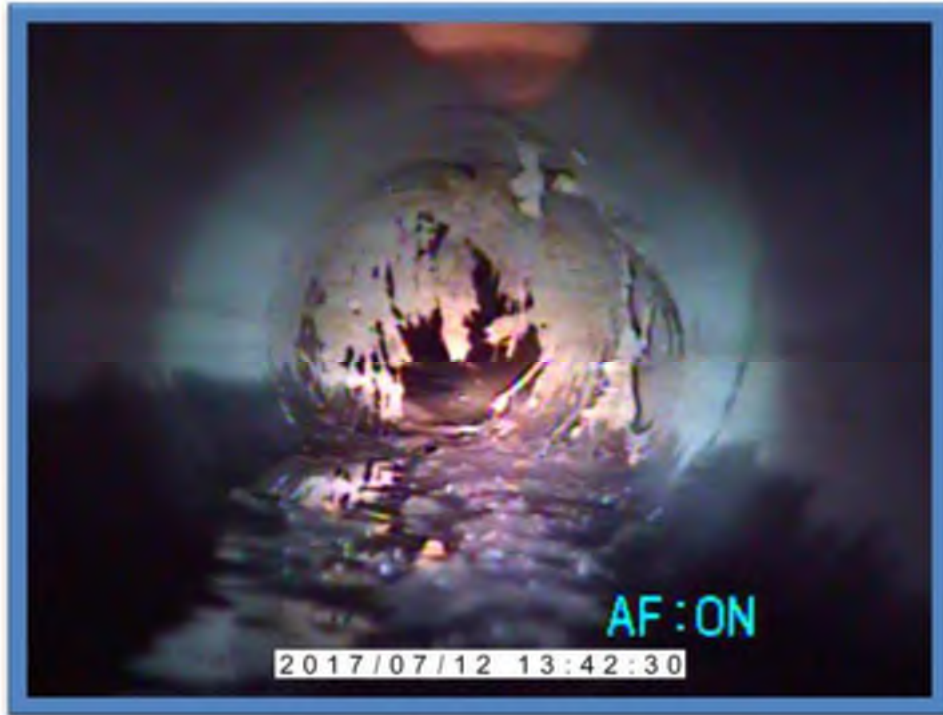
Photo 2-Holes in pipe and root intrusion

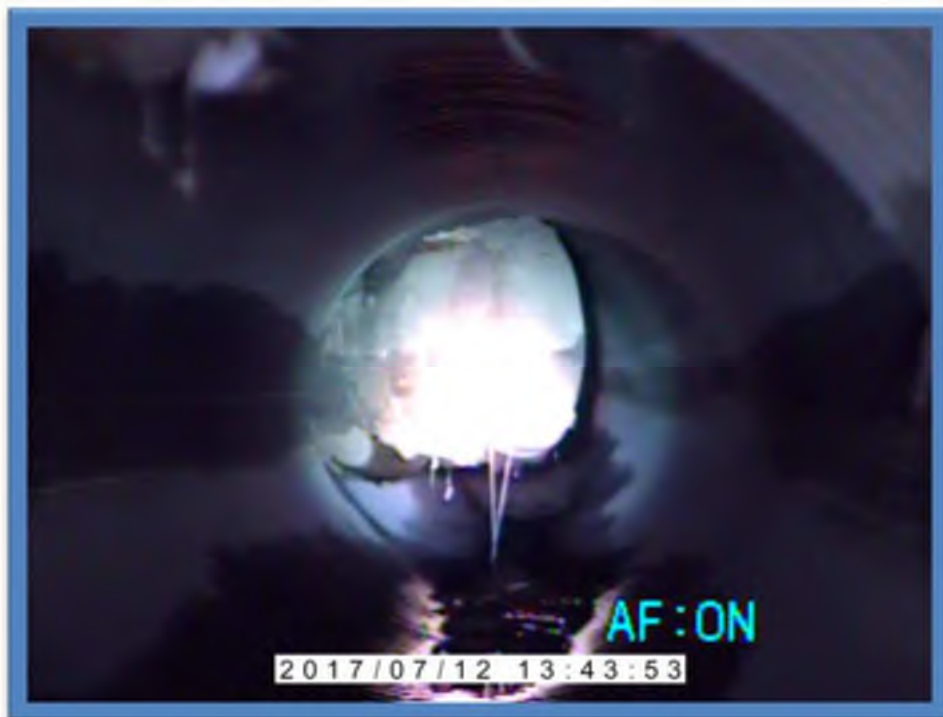
- Service pipe observed tapped in side of pipe. See photo 3.
- Pipe transitions to CPEP about 15 feet to east of manhole.

Photo 3-Service pipe connecting to pipe.

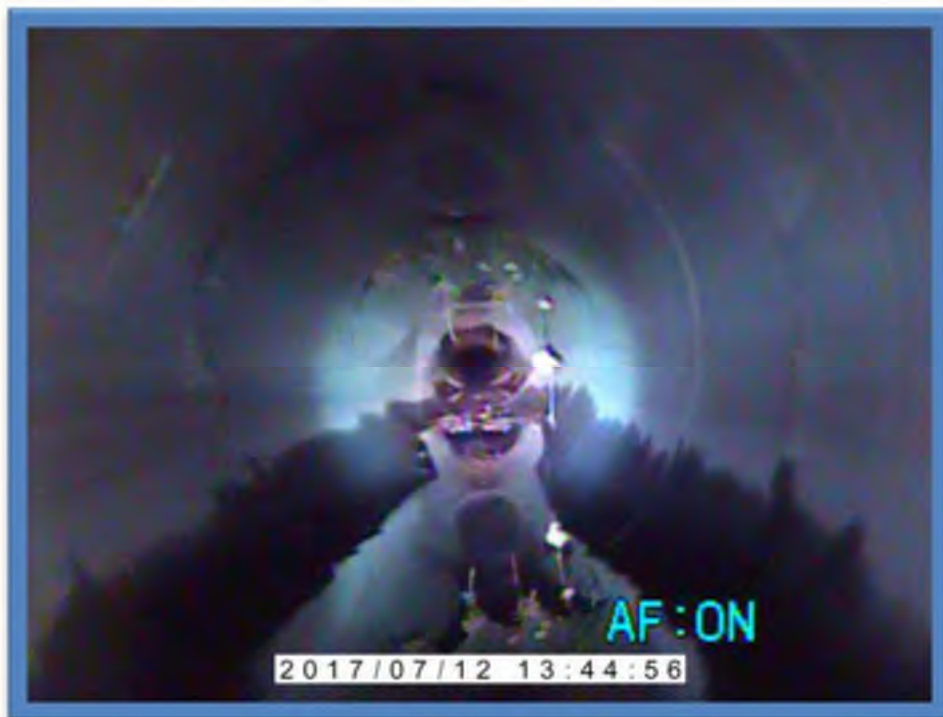
Photo 5-Hole in pipe at 10 o'clock position

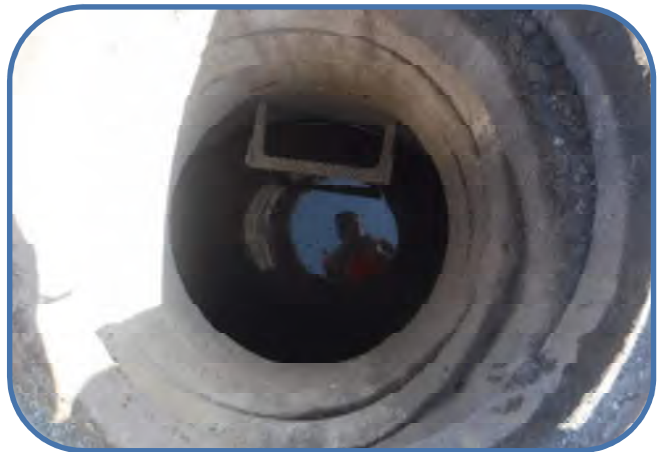
Additional Comment: Step is too far down to be of use

step photo taken looking north

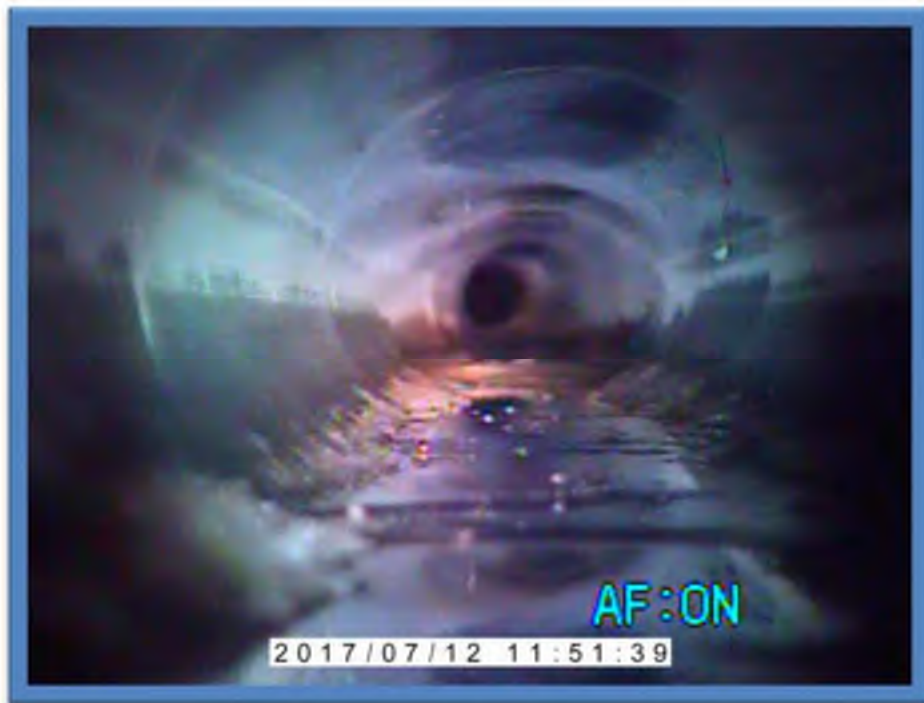
Photo 1-Ovality in CPEP pipe
